Improved Statistical Ratings for Distribution Overhead Lines (Phase 2)

Quarterly Report; September 2016

Date: 12 September 2016

T7919 OHL Conductor Temperature Monitoring Test-rig at WPD Stoke

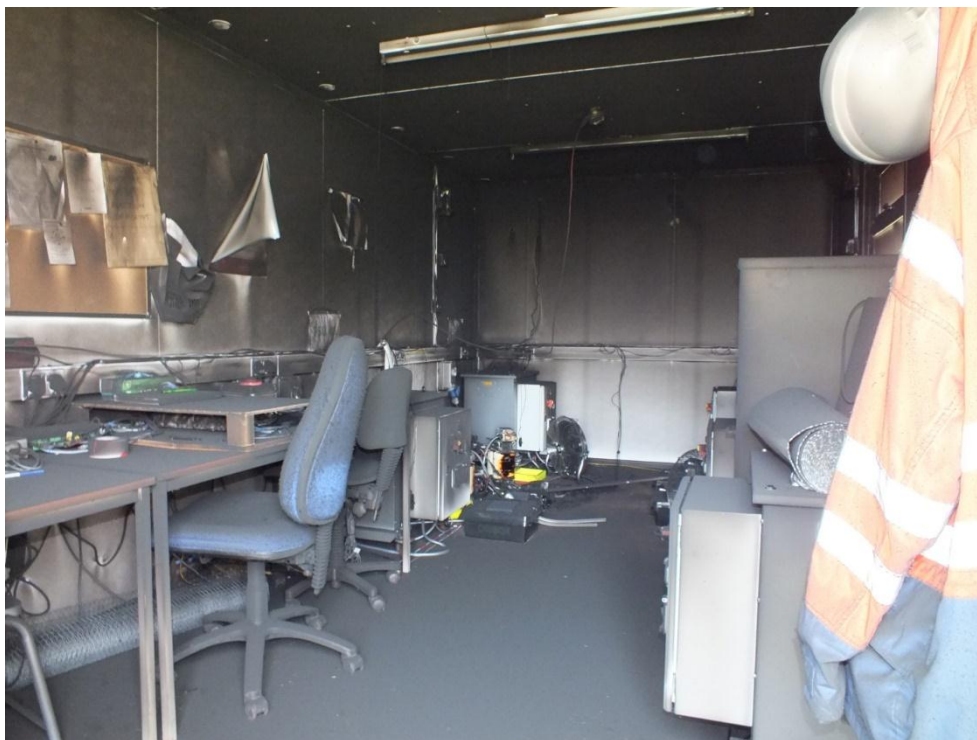
Fortunately, the fire was contained to the immediate area of the faulted equipment, although the rig porta-cabin suffered extensive smoke damage (see photographic images below). Whilst the amount of smoke damage from the resultant fire was extensive, the outcome from the fire was not catastrophic and was considered recoverable. Approximately two months of operating time has been lost due to this fire incident (June 3rd to 5th August), although it is worth noting that an immense amount of hard work and dedication by the EA Technology project team, meant that the test rig essentially became operational again on the 5th August 2016. This resulted in approximately two months of data not being collected during the fire repair process. A full Fire Incident Fault Report is included in Appendix I of this quarterly report.

Figure 1 General view inside Porta-cabin 7th June 2016

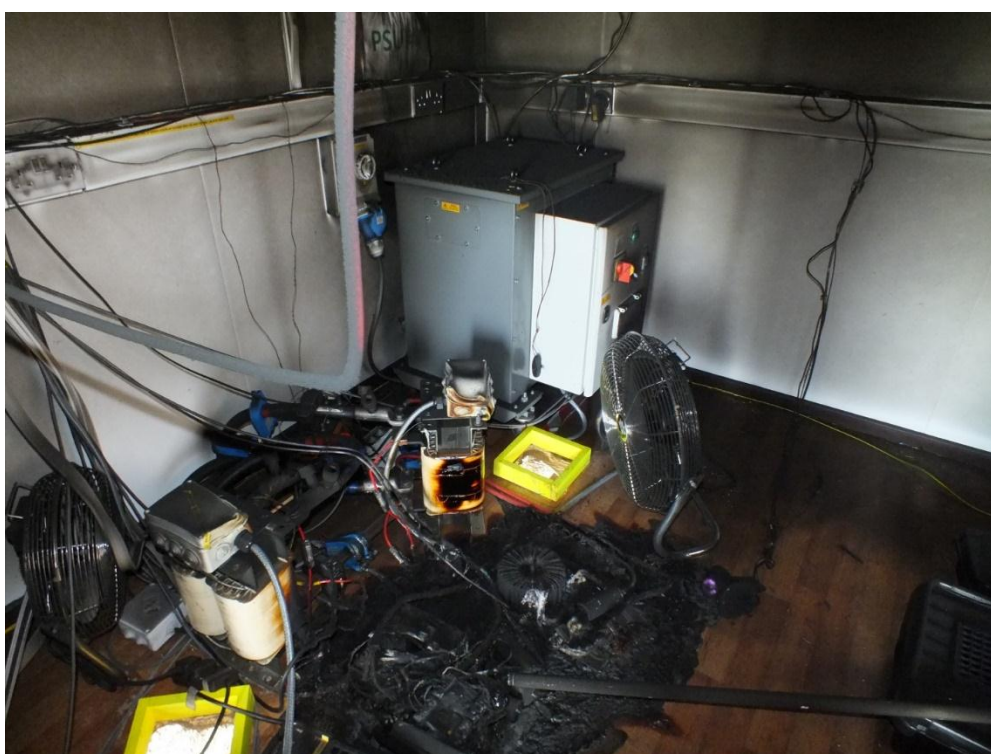
Figure 2 Fire damaged Power Factor Correction Unit 7th June 2016

The power factor correction unit consisted of a transformer to step up the rig voltage (from about 10V) to drive conventional metal can power factor correction capacitors, with a fuse on the low voltage side. The capacitors have an overpressure disconnect function and were not fused. The components were all within their ratings, and the enclosure was in a cooling forced air flow from an adjacent fan. It appears probable that the transformer overheated and failed, as no capacitor had self-disconnected. The single unit has been replaced with a pair of metal, ventilated units with a higher margin from operating to nominal ratings and separate fuses on transformer windings. The post-injection PFC is only used on the 500A circuit to reduce current drawn from the highest loaded injection transformer towards that on the other circuits. All circuits have pre-injection PFC capacitors to reduce current load on the motorised variacs.

In order to prevent recurrence of the recent fire fault incident, the rig monitoring and control equipment has been re-designed to reduce the likelihood of overheating:

- Two control transformers have replaced the original single unit; each running well below their maximum rating.
- Plastic component enclosures have been replaced with metallic alternatives.
- Air flow and powered ventilation has been increased significantly, and steel flooring sections positioned beneath the majority of rig-control equipment.

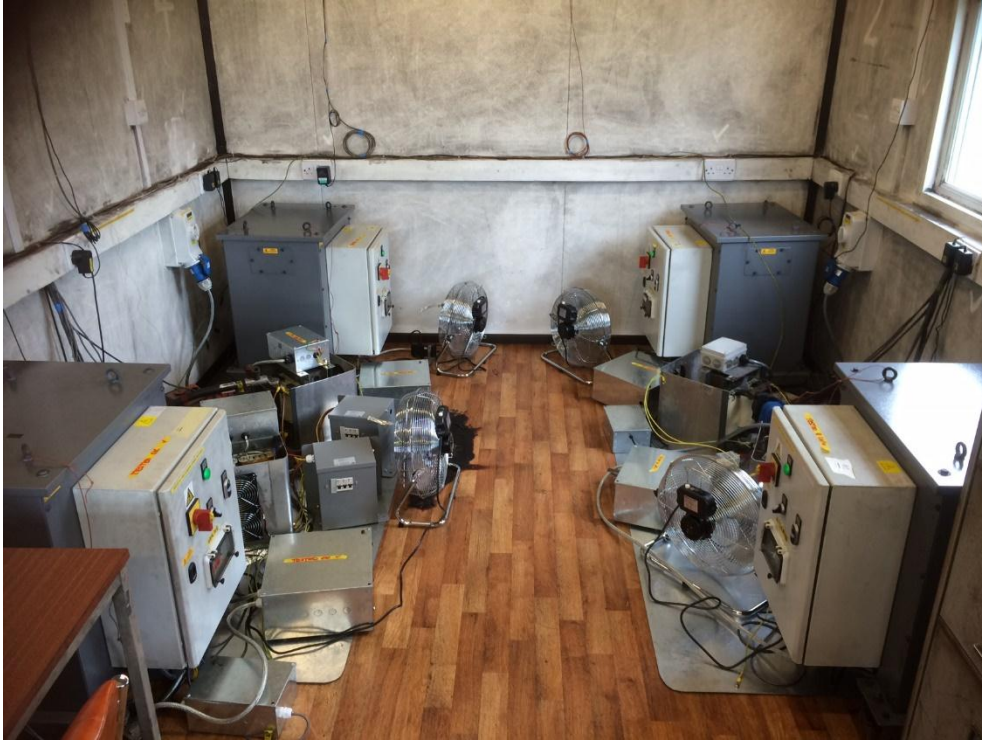
Figure 3 Porta-cabin following reparation work 5th August 2016

EA Technology project staff visited the test-rig site on numerous occasions during the fire repair stage to perform clean-up operations and repairs to various items of equipment within the porta-cabin. A number of components were removed and transported back to EA Technology’s workshops at Capenhurst, for intensive cleaning and testing. The power supply units underwent their first manufacturer’s servicing during this period. The Power Factor Correction Unit enclosure has been modified from the original specification and is now contained within two bespoke ventilated metal enclosures, with higher rated components. A number of other precautionary measures have also been instigated for preventing a reoccurrence of a similar fire incident.

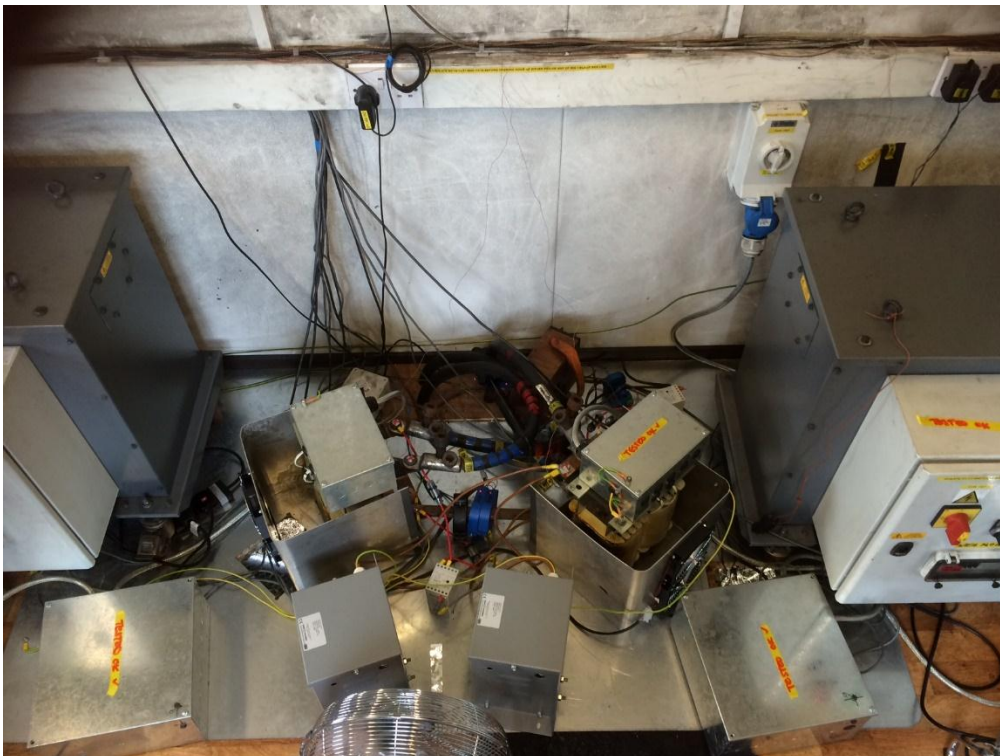
Figure 4 New/repaired test rig components 5th August 2016

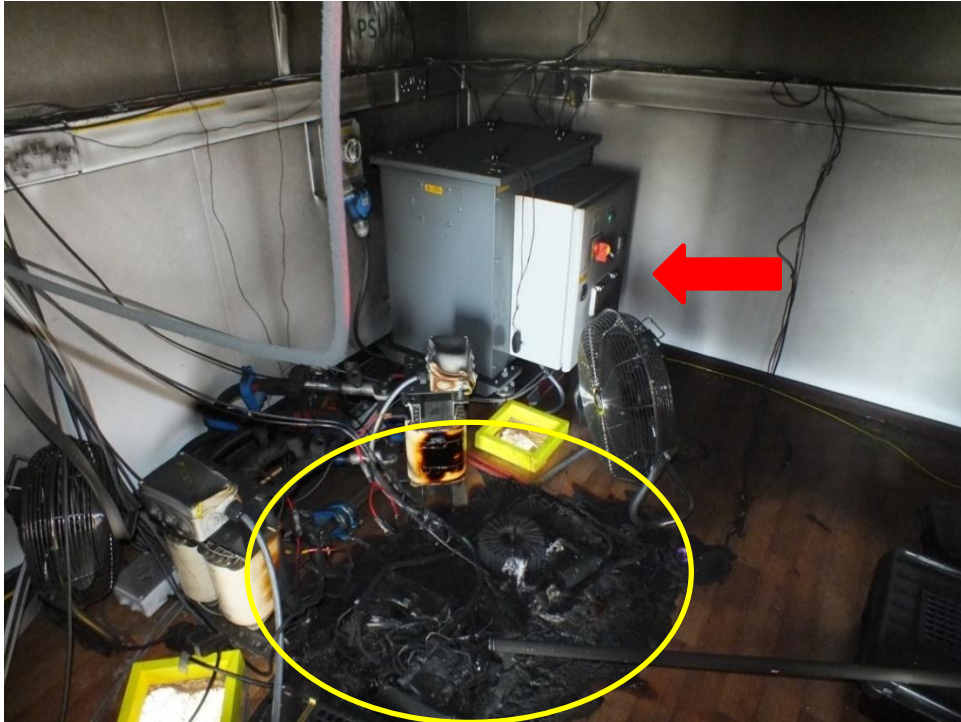
Figure 1 Location of fire within porta-cabin. Power supply unit (PSU) 4 indicated by red arrow.

The fire had originated within the rig 4 post injection transformer power factor correction enclosures that was positioned at floor level adjacent to injection transformers 1 and 4. Charred flooring material was localised co-incident with the failure which covered a surface area of approximately 70cm x 70cm (**Error! Reference source not found.** and Figure 2).

- The fire extinguishers held within the porta-cabin were covered in soot deposits and should be inspected or replaced.
- All test-rig power supply control components should be installed within metal enclosures with vents in lids and bases.
- All test-rig power supply control components, including injection transformers, associated cabling, VTs, CTs, etc. should be positioned on top of a steel grill platform raised approx. 6" above the floor in order to improve air flow and prevent heat damage to floor materials.
- Additional vents should be cut into the flooring to improve air flow.

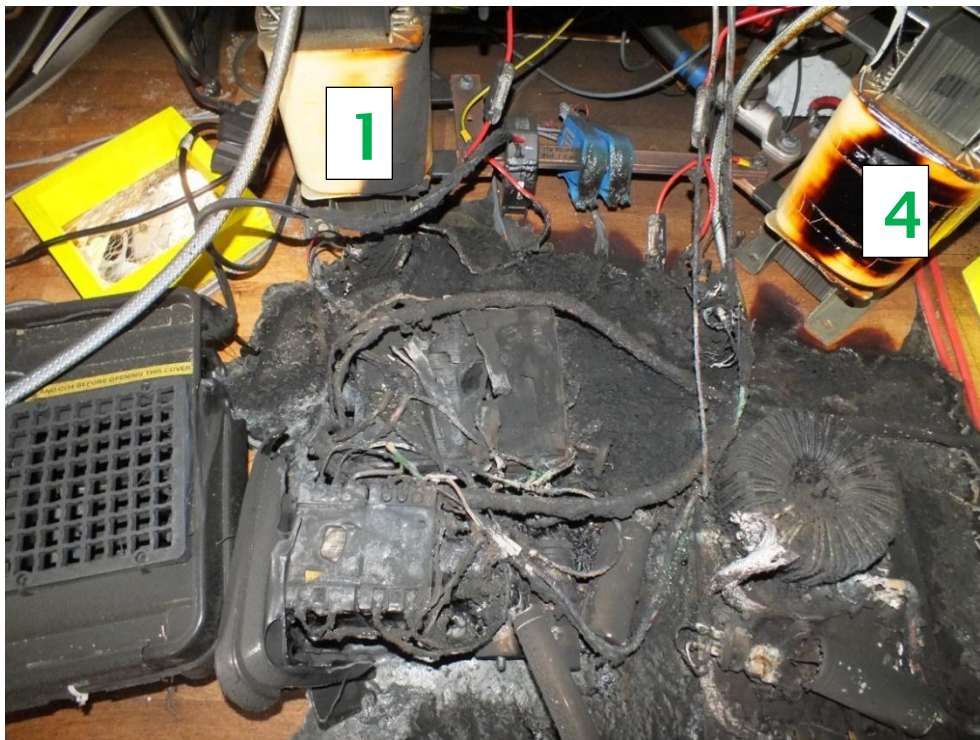
Figure 2 Charred components co-incident with origin of fire. Injection transformers 1 and 4 indicated by appropriate green numerals

- The most significant evidence of secondary thermal damage within the porta-cabin was as follows:
 - External surfaces of injection transformers 1 and 4 and associated termination boxes
 - Current and voltage transducers (CTs and VTs), associated LV cabling, thermocouples, etc.
 - Webcams
 - Wall mounted cable trunking for fire alarm cabling and ceiling mounted smoke sensor
 - Ceiling mounted fluorescent light fitting(s)
 - Floor standing fan(s)
 - Wall mounted extractor fans and associated cabling, trunking, switches, etc.
 - Wall mounted file holder
 - Fire alarm sounder
 - Domestic 6-way RCD protected consumer unit
- There were significant levels of carbon deposits within the plug-top ports of all 240V 13A sockets that caused instant tripping to RCD protection when tried during commencement of initial clean-up operation.
