REPORT

Laboratory Examination and Testing of Recovered Overhead Line Conductor.

Prepared for: UK Power Networks

Report No: A2469_1
Document Version: Issue 2
Date: 13 April 2021

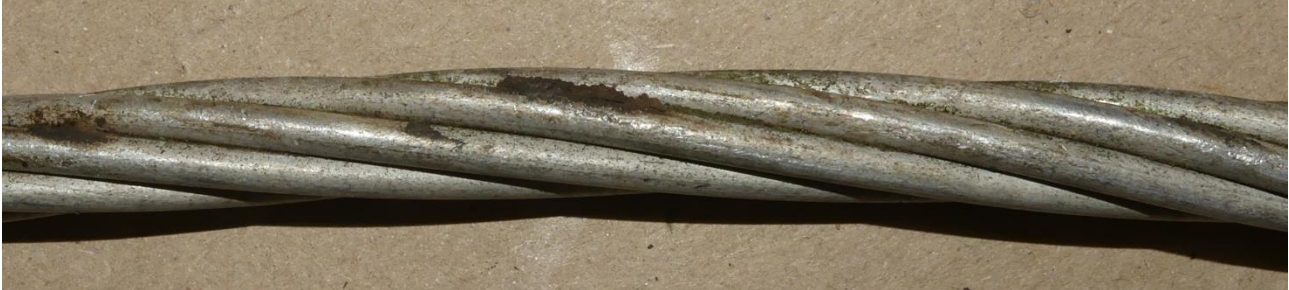
The external surface of the conductor was found to be in a relatively good condition although greyed due to environmental exposure (Figure 1). There was some lichen growth across the length of the conductor.

Figure 1 External surface of the conductor – Tag ID 271

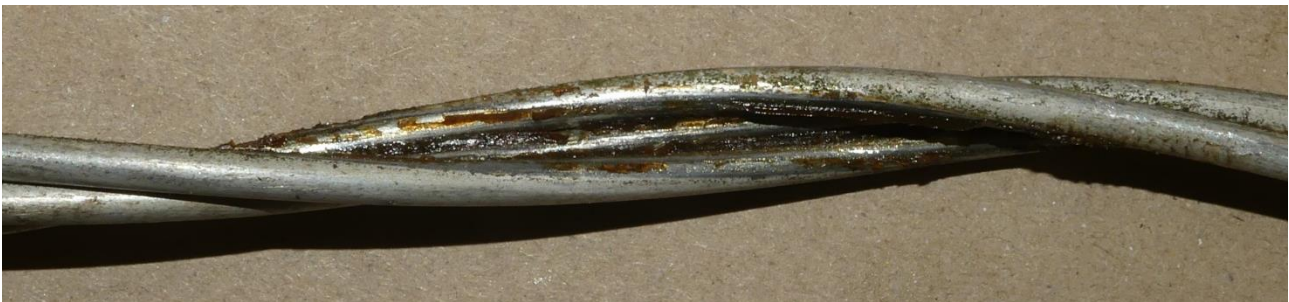
Internally, the conductor was relatively clean of debris ingress and exhibited only a low level of corrosion product. An adequate quantity of grease was present at the aluminium/steel strand interface. Overall, this grease was golden in appearance and pliable (Figure 2).

Figure 2 Inner surface of outer aluminium strands – Tag ID 271

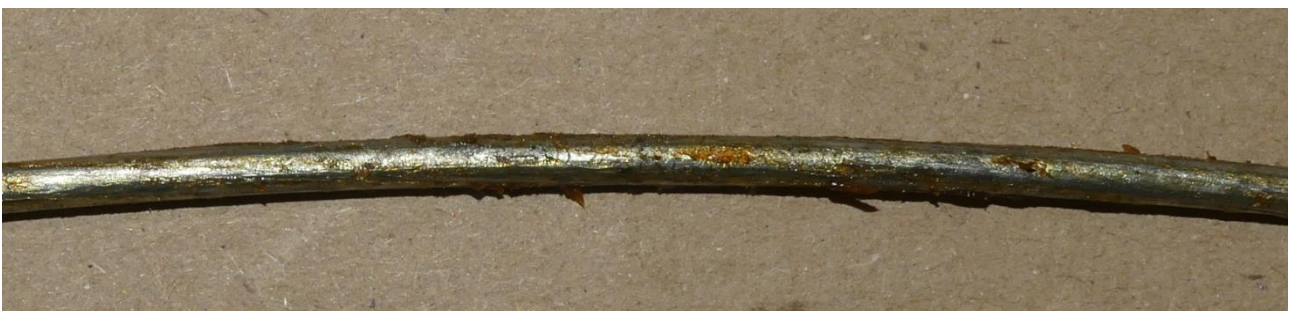
The core steel strand was coated in an adequate quantity of grease (Figure 3). This grease was overall both golden in appearance and pliable. Cleaned of grease the steel core strand displayed no evidence of degradation.

Figure 3 Condition of core steel strand – Tag ID 271

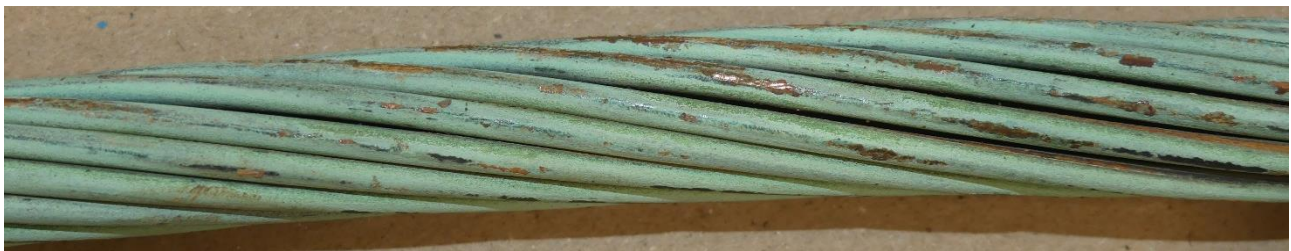
The external surface of the conductor was found to be in a relatively good condition. There was a normal level of verdigris (a greenish copper carbonate corrosion product) across the external surface (Figure 4).

Figure 4 External surface of the conductor – Tag ID 140

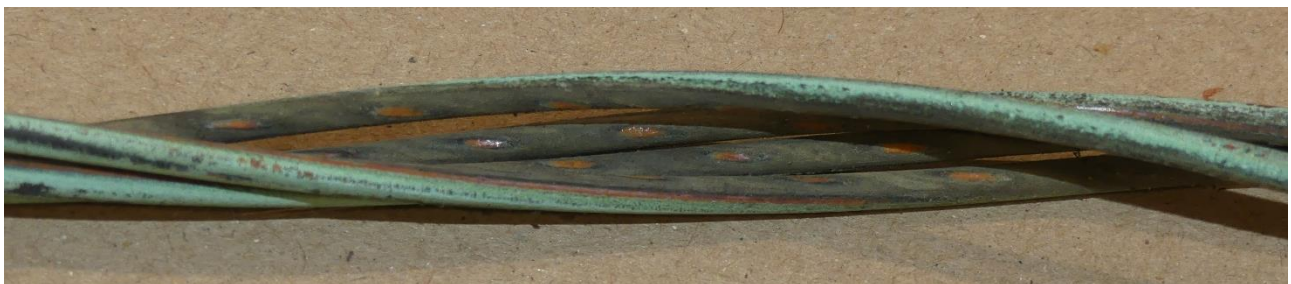
A low level of debris ingress was observed between the external conductor strands. Although the inner surface of the outer conductor strands exhibited a near full covering of corrosion product, this appeared to be mostly superficial with no evidence of significant material loss (Figure 5).

Figure 5 Inner surface of copper strands – Tag ID 140

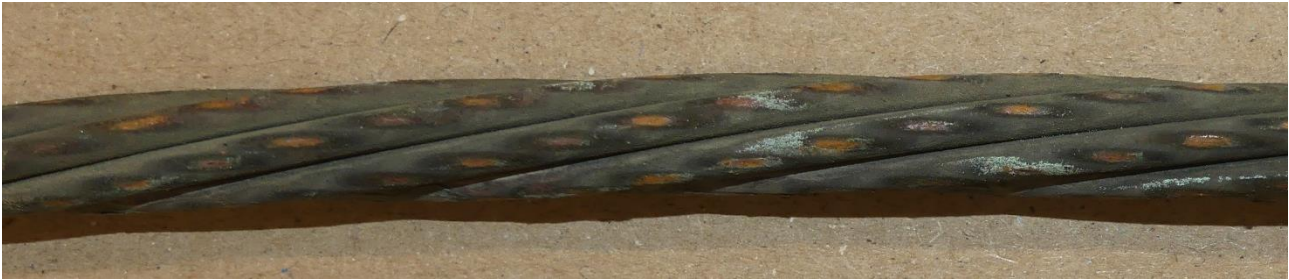
The outer surface of the inner copper strands displayed a near full covering of corrosion product. Again, however, this corrosion appeared to be mostly superficial with no evidence of significant material loss (Figure 6).

Figure 6 Outer surface of inner copper strands – Tag ID 140

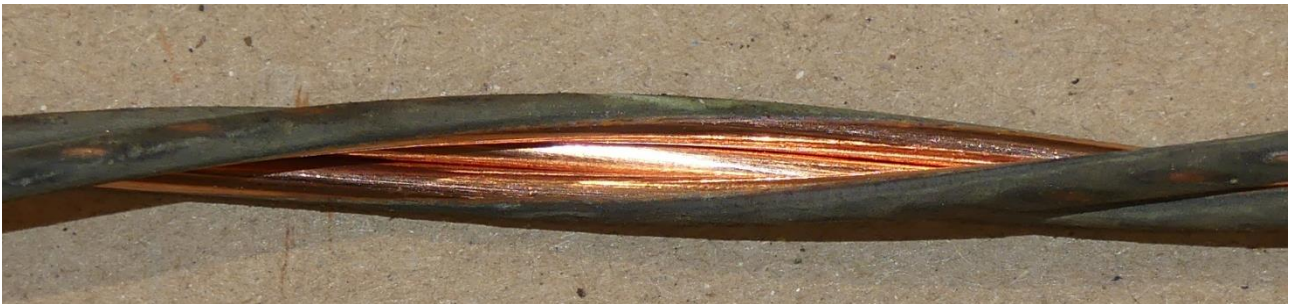
The inner surface of the inner copper strands was both clean of debris ingress and free from significant corrosion product (Figure 7).

Figure 7 Inner surface of inner copper strands – Tag ID 140

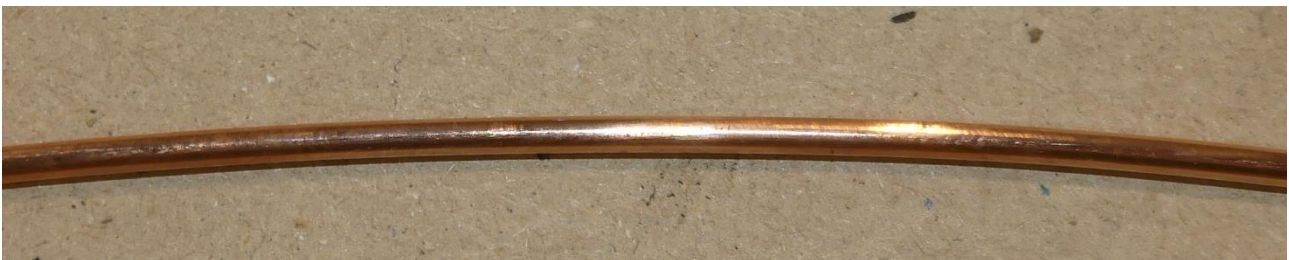
The core copper strand was found to be bright in appearance, clean of debris ingress and free from significant corrosion product (Figure 8).

Figure 8 Condition of core copper strand – Tag ID 140

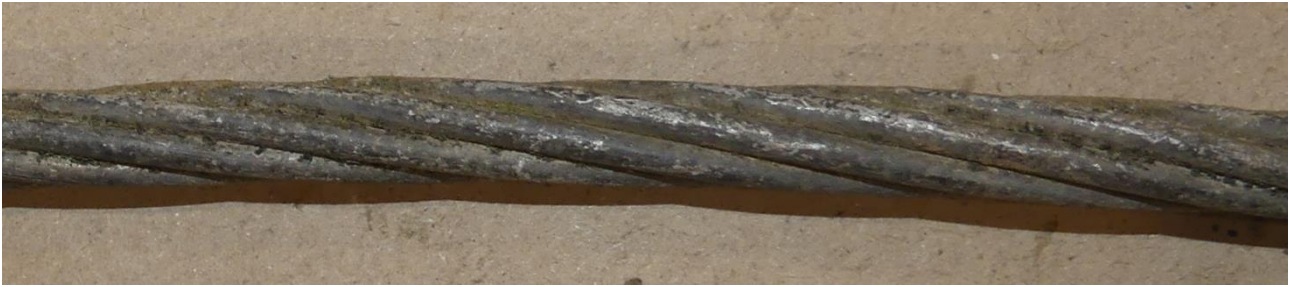
The external surface of the conductor was found to be in a relatively good condition although greyed due to environmental pollution (Figure 9).

Figure 9 External surface of the conductor – Tag ID 005

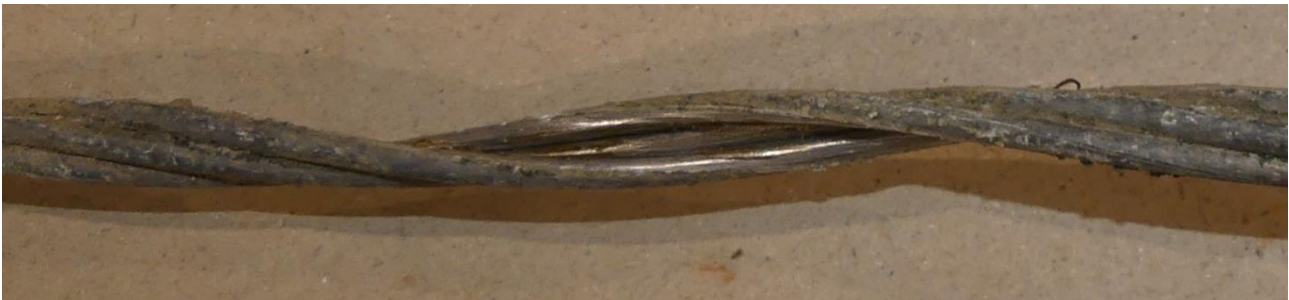
Internally, the conductor was relatively clean of debris ingress and free from significant corrosion product (Figure 10). The inner surface of the outer aluminium strands was coated in a low level of grease. Overall, this grease was both golden and pliable, however some hardening of the grease was observed in locations.

Figure 10 Inner surface of outer aluminium strands – Tag ID 005

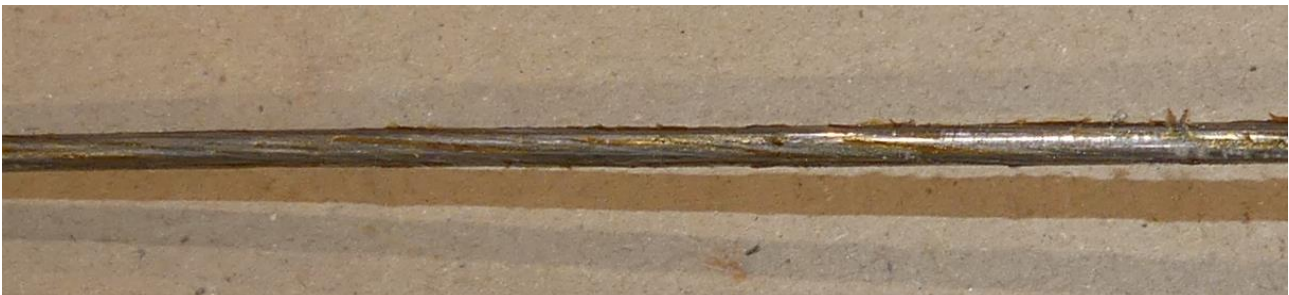
The core aluminium strand was coated in a low quantity of grease (Figure 11). This grease was overall both golden in appearance and pliable, however some hardening of the grease was observed in locations. Cleaned of grease the aluminium core strand displayed no evidence of degradation.

Figure 11 Condition of core aluminium strand – Tag ID 005

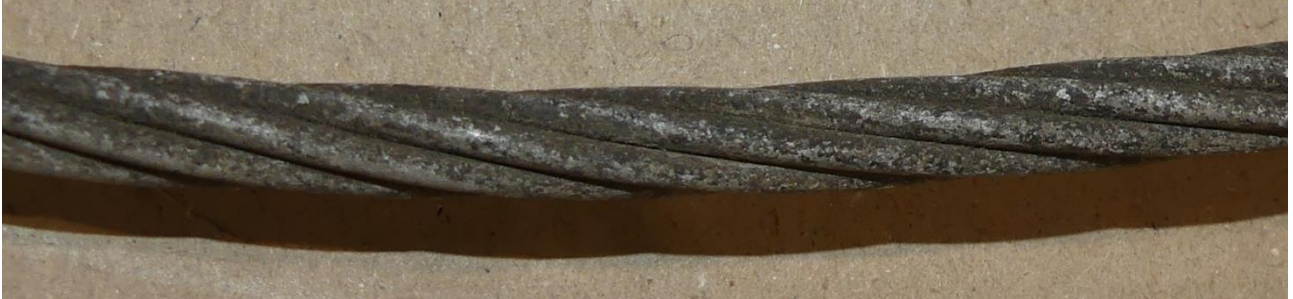
The external surface of the conductor was found to be in a relatively good condition although greyed due to environmental pollution (Figure 12).

Figure 12 External surface of the conductor – Tag ID 001

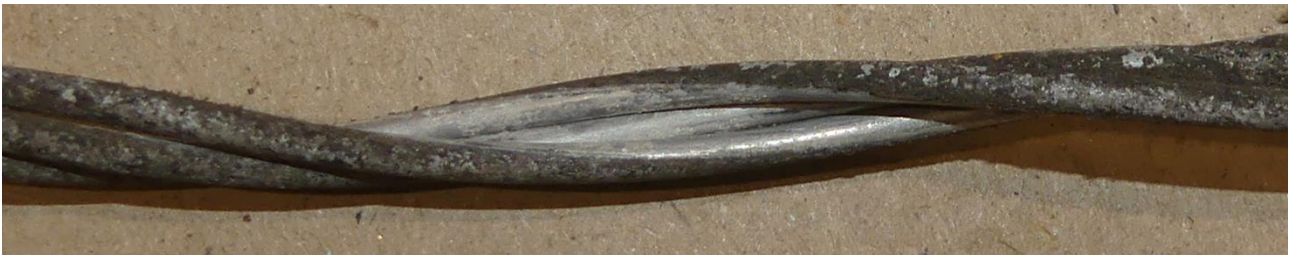
A low level of debris ingress was observed between the external conductor strands (Figure 13). The inner surface of the outer aluminium strands was free from significant corrosion product.

Figure 13 Inner surface of outer aluminium alloy strands – Tag ID 001

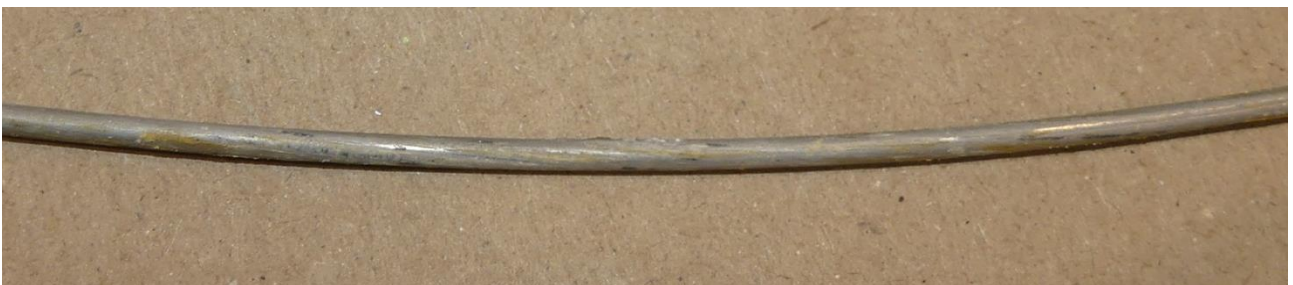
The core aluminium alloy strand was found to contain a negligible quantity of grease (Figure 14). Although slightly dulled due to debris ingress, the core strand showed no evidence of significant degradation.

Figure 14 Condition of core aluminium alloy strand – Tag ID 001

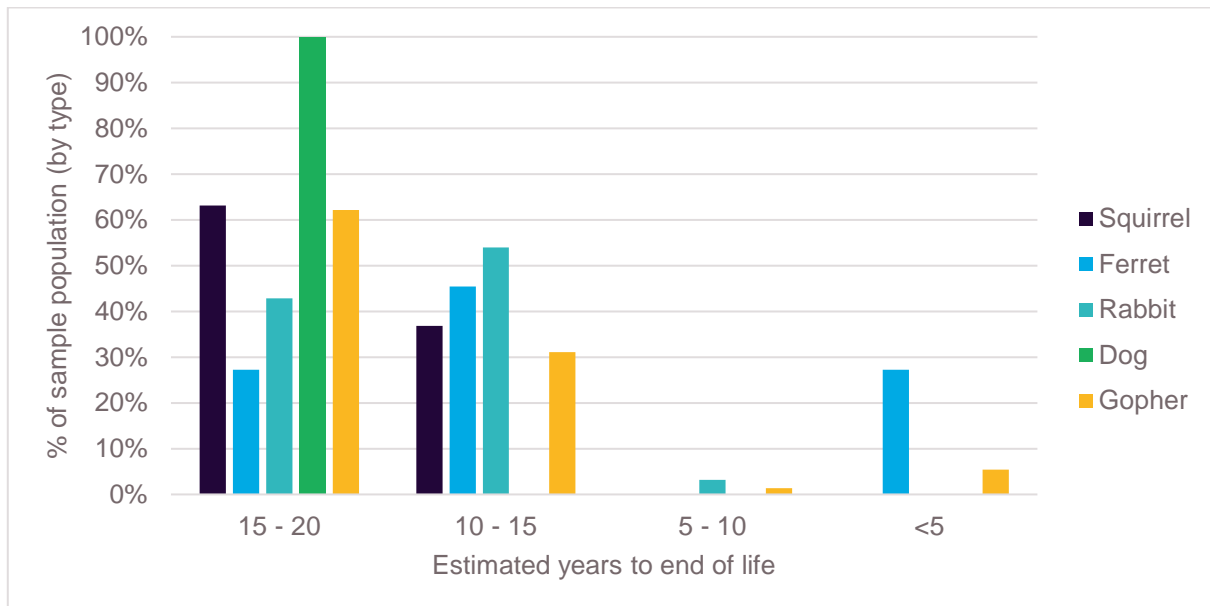
Figure 16 Years to end of life against percentage of sample population

Figure 16 shows that the majority of the ACSR samples (52% or 91 of the 173 samples) have an estimated 15 to 20 years remaining life. It is important to note that the 15-20 years estimate is considered to be a minimum, and it is possible that the remaining life of some of the samples would be higher than this value. Approximately 94% of the samples (163 of the 173 samples) tested had a remaining life of 10 or more years.

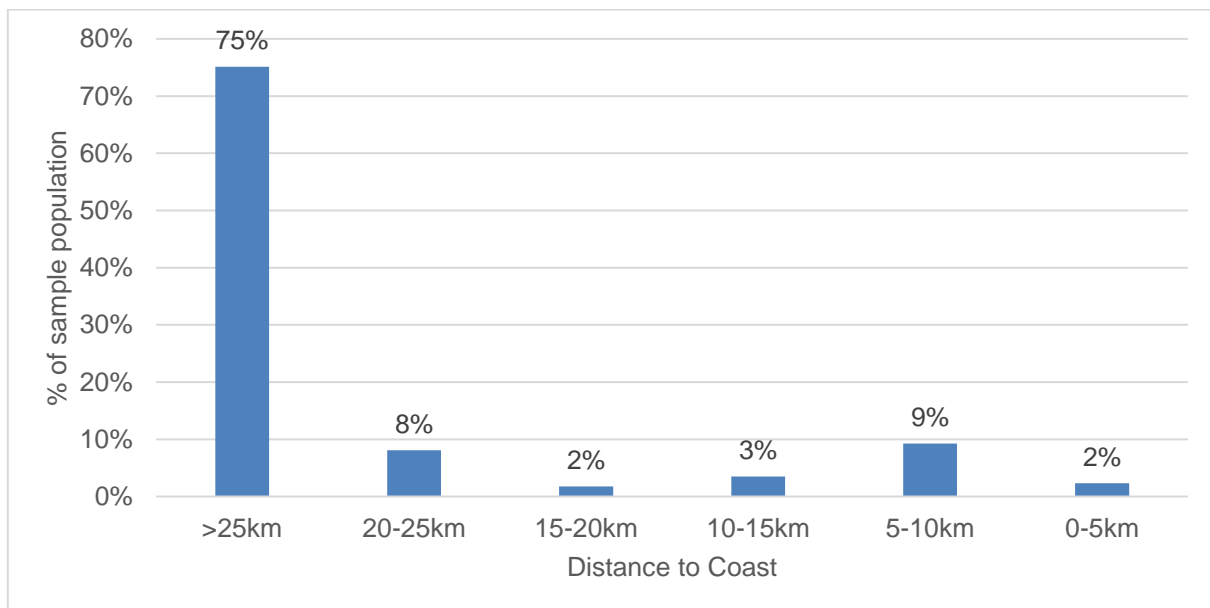
The data summarised in the following graph shows that the majority of samples (75% or 130 of the 173 samples) were located 25km or more from the coast; typically beyond 25km coastal effects are not seen to be significant contributing factor in the degradation of assets and as such this is considered to be an acceptable upper limit of distance banding for the purpose of the statistical analysis.

Figure 17 Distance to Coast against sample population for ACSR Conductor Samples

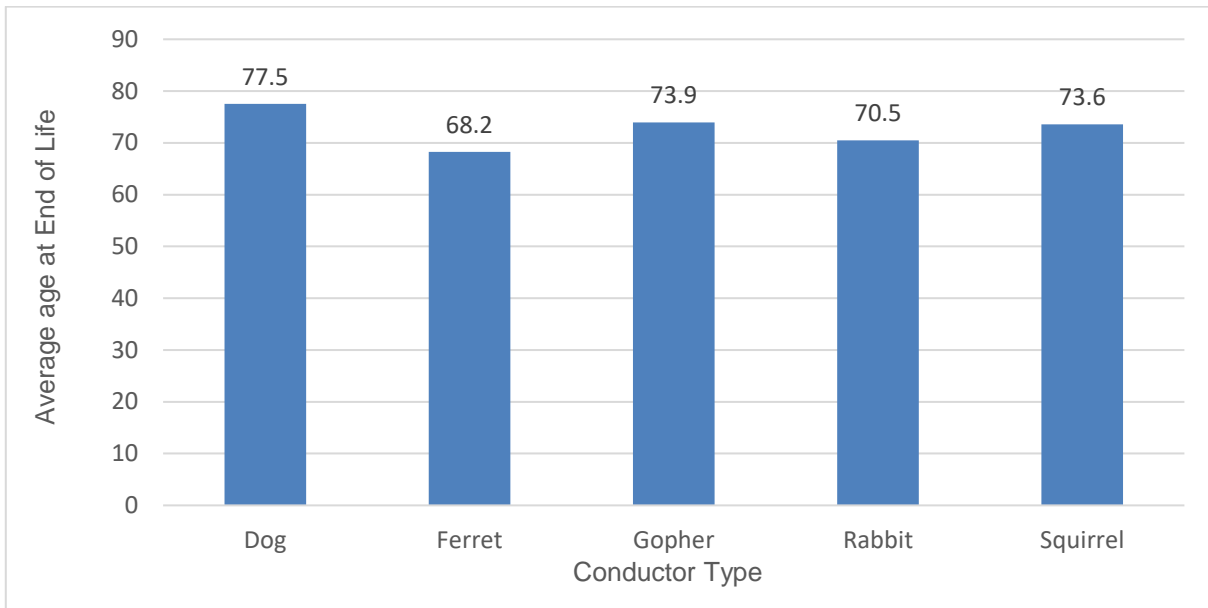
The following graph shows the average age at end of life by conductor type. This shows that the average age at end of life varies from approximately 68 years to 78 years.

Figure 19 Age at End of Life by conductor type (173 samples)

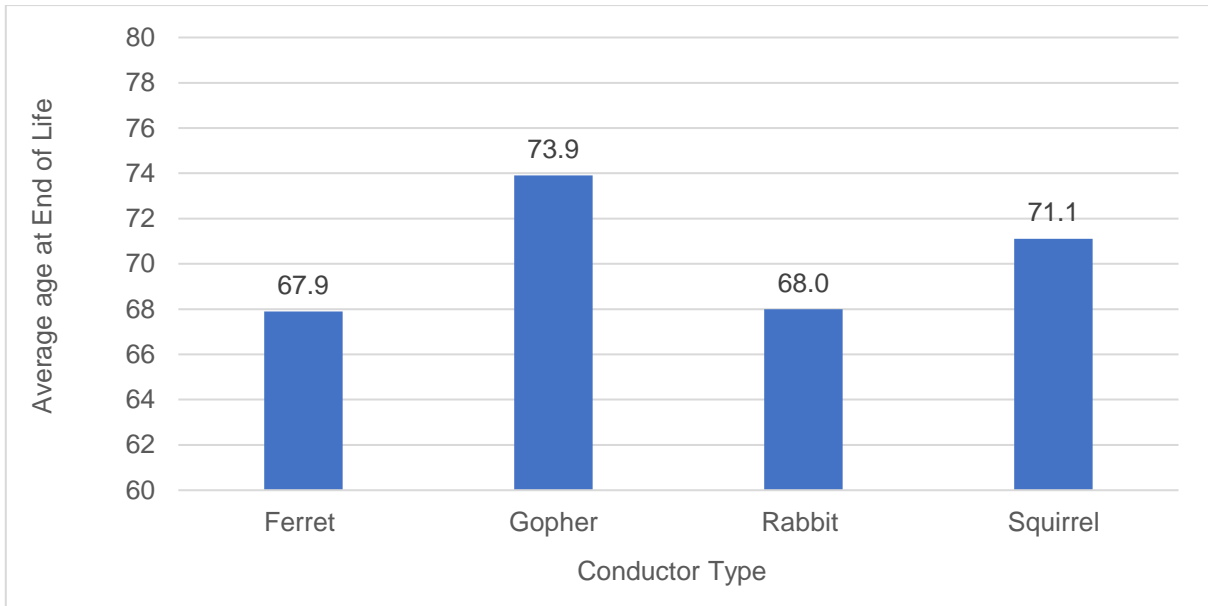
Figure 20 Age at End of Life by conductor type (excluding assets with 15 – 20 years remaining life (82 samples))

This shows that the average age at end of life varies between approximately 68 years and 73 years. Ferret has the shortest age at end of life, whilst Gopher has the longest life. Across all conductor types, the average age at end of life is 70 years.

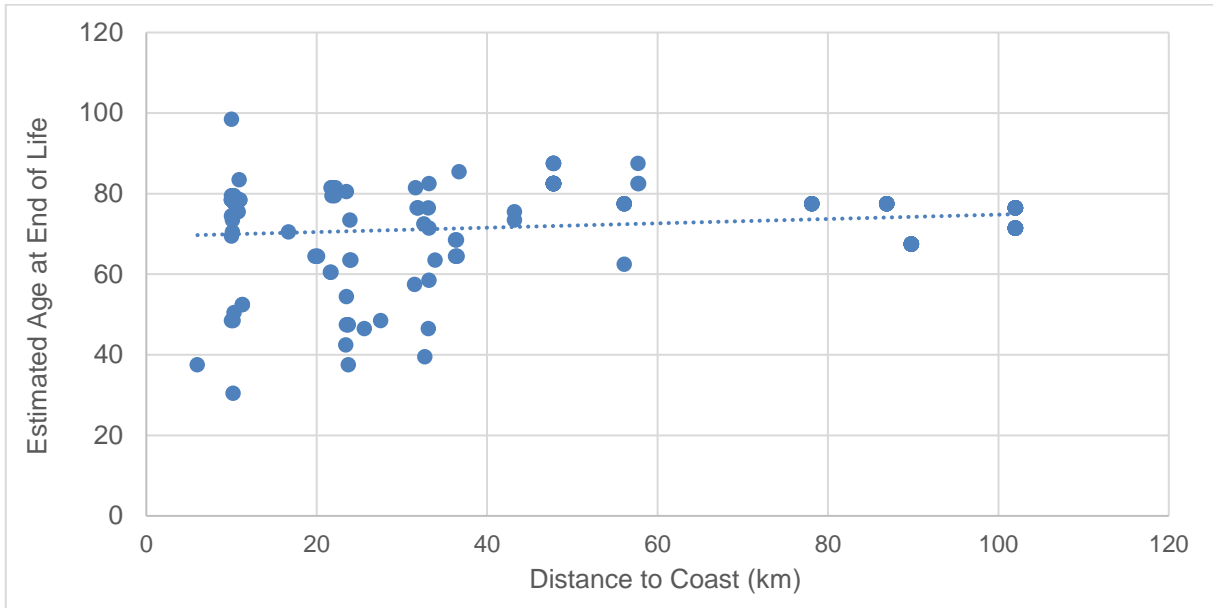
Figure 21 Scatter plot of age at end of life by distance to coast, all samples

When all samples are considered, the estimated age at end of life ranges from 30.5 years to 98.5 years. When assets with a remaining life of 15 to 20 years are excluded, the age at end of life varies between 37.5 years and 82.5 years. Thus, indicating there are both young assets and old assets with a remaining life of 15 to 20 years, with the youngest asset at 13 years old and the oldest at 81 years. This suggests that the age of some ACSR conductors can approach 90 to 100 years, which is considerably above the average across the sample population.

Figure 21 and Figure 22 both suggest a trend of decreasing age at end of life with decreasing distance to coast, however, there is a considerable amount of variation and the trendline does not represent a good fit with the data. The data presented in Figure 22 is presented again in Figure 23 but now by conductor type.

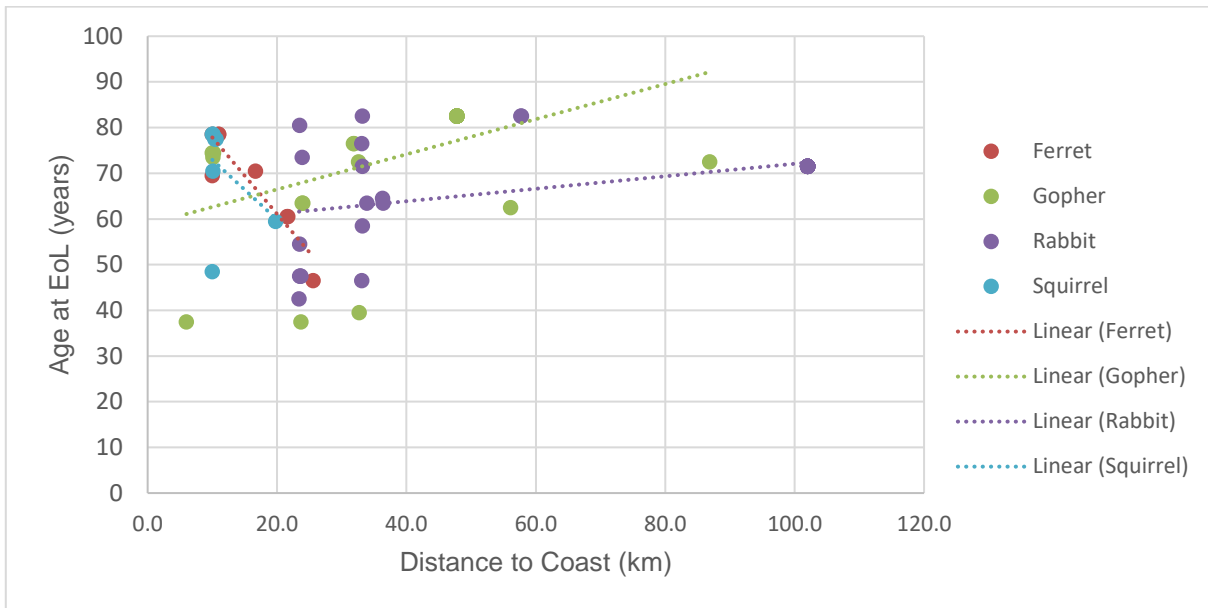
Figure 23 Age at end of life by distance to coast and conductor type, excluding samples with 15 to 20 years remaining life

There is no data for conductor type Dog shown in Figure 23 as all samples were considered to have 15 to 20 years remaining life and are therefore excluded. There is evidence to suggest a trend of decreasing age at end of life with decreasing distance to coast for conductor types Rabbit and Gopher, but again there is considerable variation in age at end of life for any distance to coast. However, for Ferret and Squirrel, the trend is reversed. As highlighted in Table 23, Ferret has a high number of asset with no grease, which may be skewing the results shown in Figure 23. Therefore, these are excluded in Figure 24, which also excludes samples situated more than 50km from the coast, as it would be expected that the impact of distance to coast is much reduced the further an asset is from the coast.

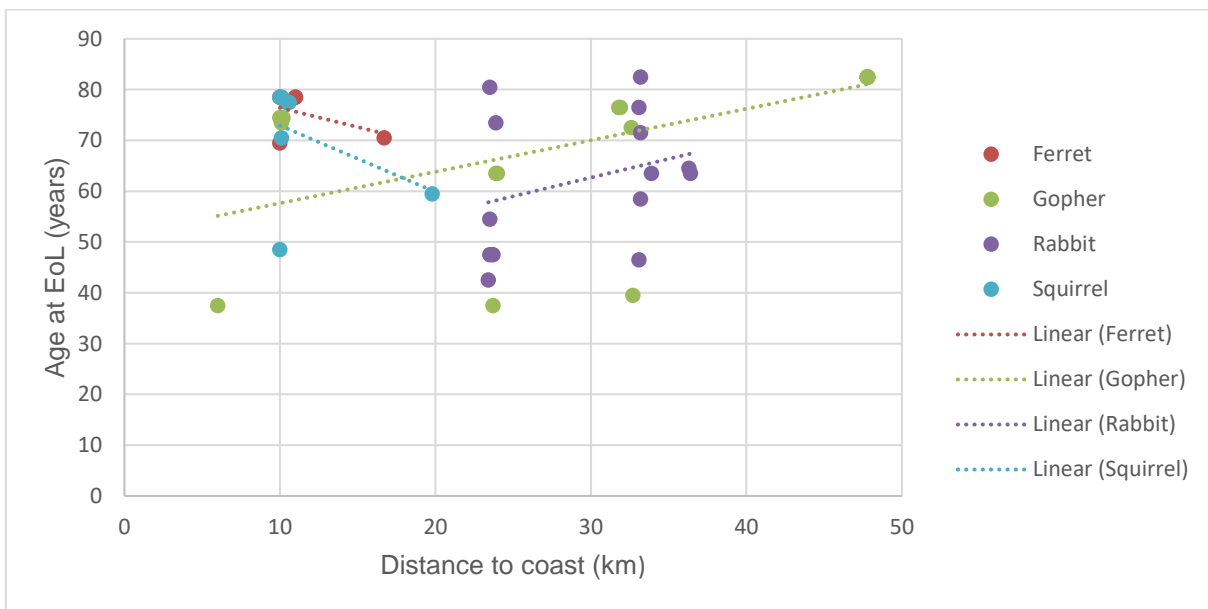
Figure 24 Age at EoL vs. distance to coast (asset <50km) by conductor type, excluding samples with 15 to 20 years remaining life

Figure 24 shows that excluding the impacts of no or minimal grease, and removing assets situated a long way from the coast, still suggests a trend of reduced life for assets that are situated closer to the coast for Gopher and Rabbit. However, there is still significant variability, i.e. linear regression does not yield a strong correlation. In the case of Squirrel and Ferret, the results might suggest a ‘reverse’ trend. However, it is important to note that the sample size for these assets is very small, and the results are skewed by one or two samples.

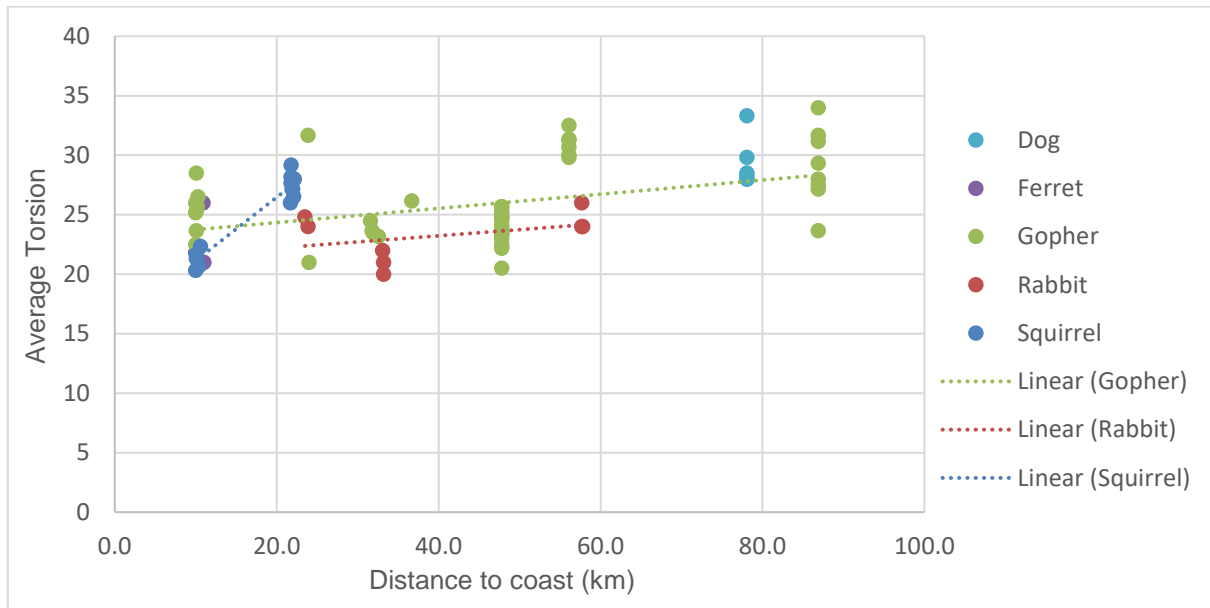
Figure 27 Torsion results vs. distance to coast by conductor type (samples aged 60 to 70 years old)

Figure 27 above shows the same data as that in Figure 26, but presented by conductor type. Linear regression indicates that distance to coast alone does not provide a reliability indication of the torsion strength of the Gopher and Rabbit samples aged 60 to 70 years. Linear regression analysis does indicate a good correlation exists for Squirrel. However, the sample size is very small, and comprises 13 assets which form two distinct clusters, with half the samples located at approximately 11km from the coast and the other half situated at approximately 22km from the coast. The line of best fit (the dashed lines in Figure 27) is significantly steeper for Squirrel compared to Gopher and Rabbit. However, there are no Squirrel samples located a long way from the coast (as is the case for Gopher and Rabbit), therefore, more Squirrel samples located further from the coast would be required to be able to draw any firm conclusions.

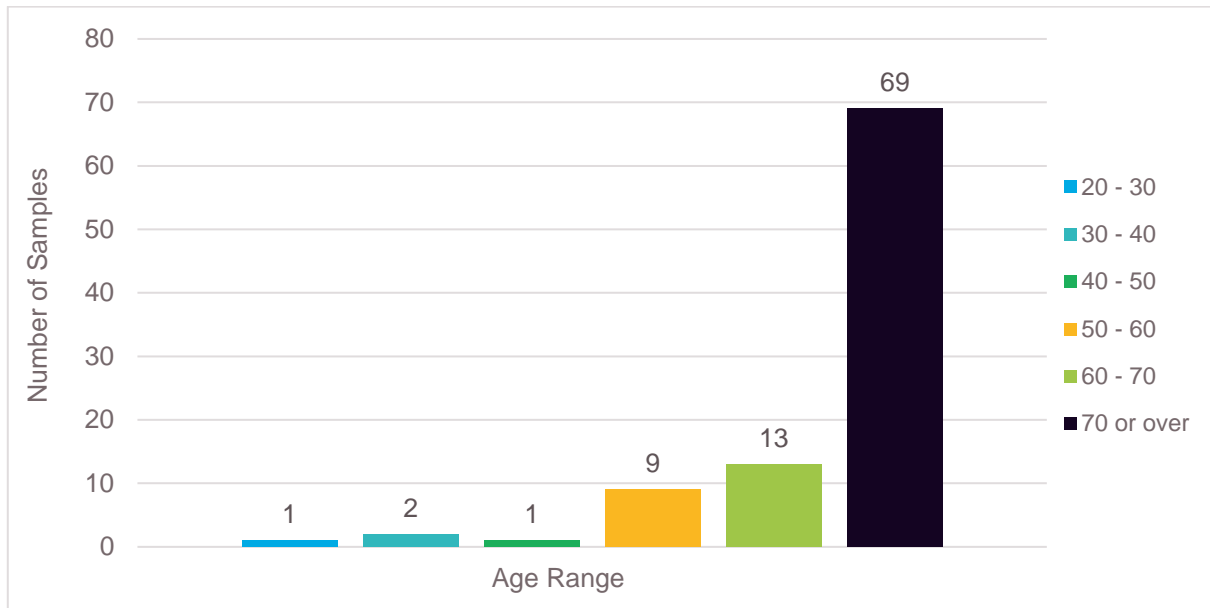
The ages of the samples ranged from 25 years old to 88 years old, with the majority (69 of the 95 samples, or 72%) aged 70 or over.

Figure 28 Years of Cu Samples

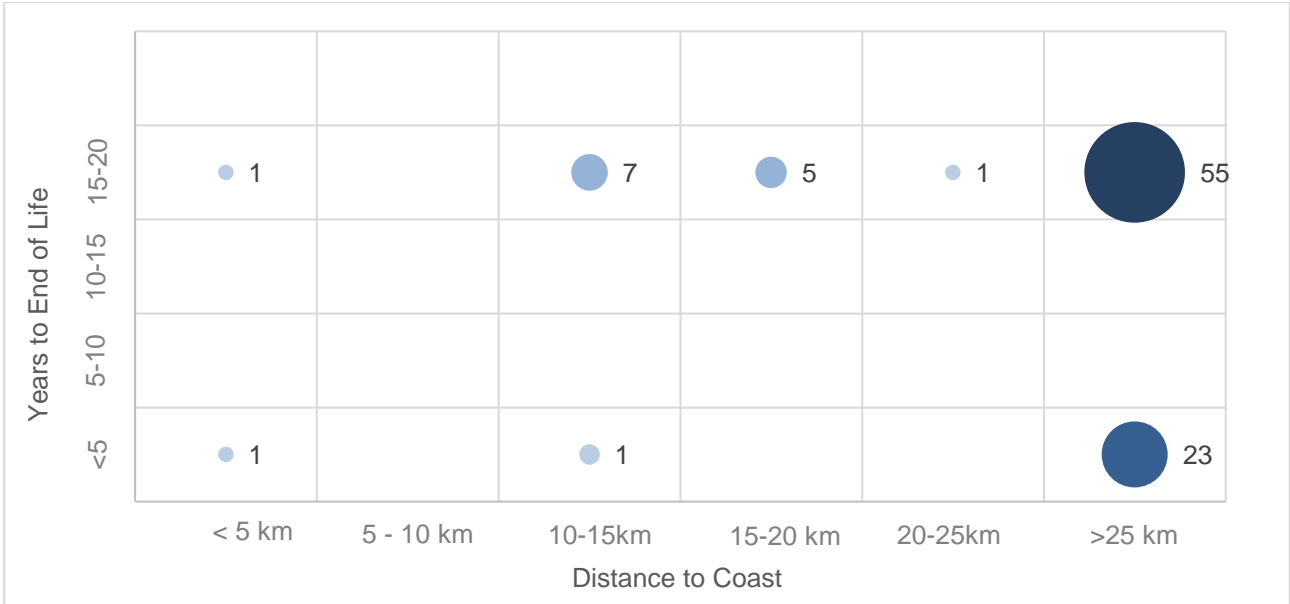
Figure 31 Years to End of Life by Distance to Coast (as a heat map)

The data shown in Figure 31 presents Years to End of Life vs Distance to Coast as a heat map, where the size of the marker indicates the number of samples with those criteria, i.e. there are 7 samples that are located 10-15km to the coast with 15-20 years remaining life. Figure 31 shows there is very large cluster of samples (55 of the 95 samples) located more than 25km from the coast and with at least 15 to 20 years of remaining life. This combined with the limited numbers of samples located close to the coast, gives low likelihood of finding a correlation between distance to coast and conductor life.

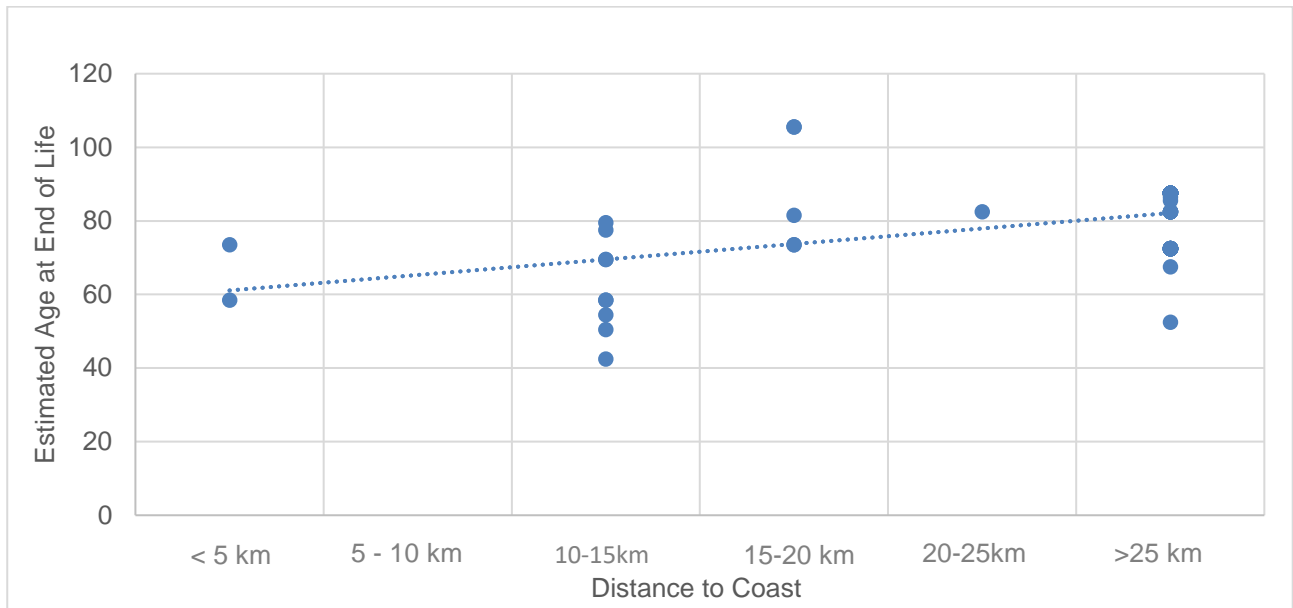
Figure 32 shows the same data, but now as a scatter plot showing the expected age at end of life (i.e. sample age plus remaining years to end of life). The years to end of life is taken as the mid-point of the expected range, so for an asset of 50 years with an estimated 15 to 20 years of remaining life, the expected age at end of life is taken to be 67.5 years.

Figure 32 Estimated Age at End of Life by Distance to Coast 9 (all 95 Cu samples – scatter plot)

The estimated age of the conductor samples at the end of life ranges from 42.5 years to 105.5 years. However, it is important to note that the results of analytical tests only give a years to end of life **of up** to 15 to 20 years, with a recommended interval of 15 years for resampling. Therefore, the upper limit on years to end of life is a minimum rather than an expectation, making it difficult to use as a predictor of useful life. Figure 33 below presents the results for samples where the years to end of life is less than 5 years.

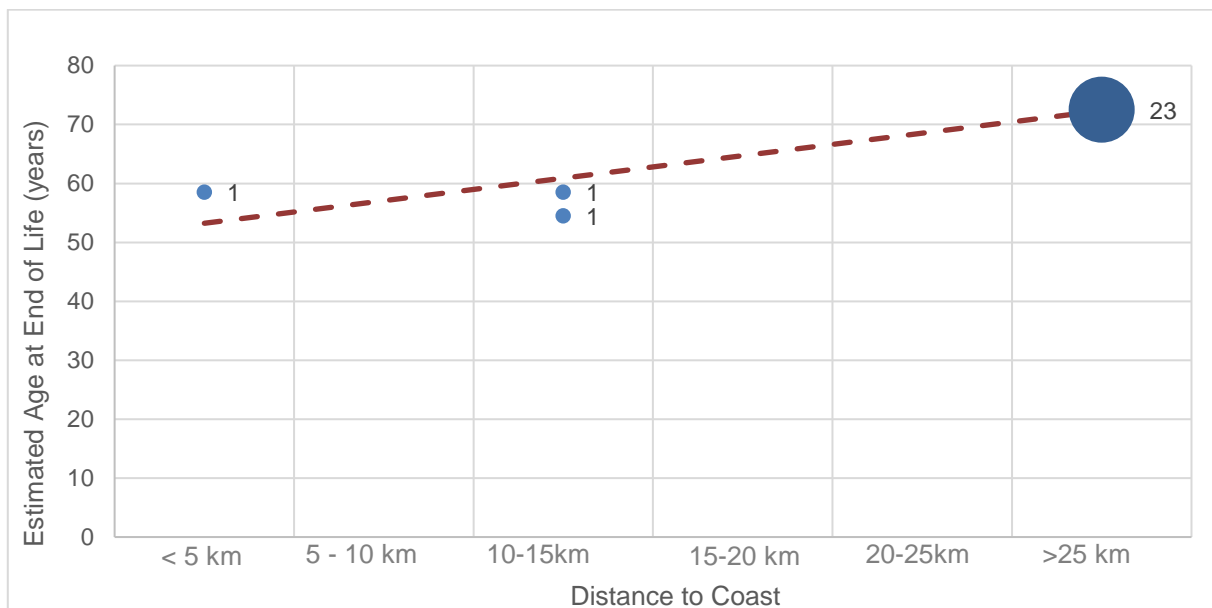
Figure 33 Estimated Age at End of Life by Distance to Coast (Cu Samples with <5 years to End of Life)
