Powerful-CB

SDRC 9.2.1:

Install and Commission Solution at an 11kV Substation

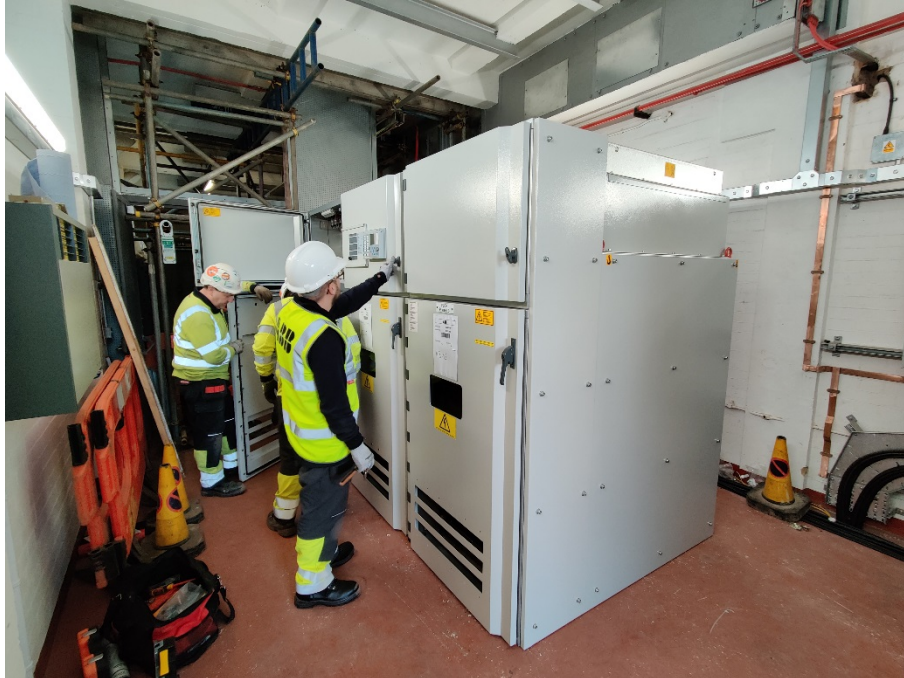
Figure 1 FLCB installation in progress

Following the preparation of the room, the FLCB was delivered to site and installed in parallel with the busbar extension works necessary to connect the FLCB to the network. The switchgear at the trial substation was manufactured in 1968 which meant that spare panels were not readily available for extending the existing busbar; however, panels from another substation that was undergoing an upgrade were redeployed to this site. Similarly,

due to the age of the equipment on the site, there were limited resources who possessed the necessary skills to complete the busbar extension of this specific type. As such, the two-fold issue of spare part availability and equipment specific expertise due to the age of substation equipment must be considered for the future application of FLCBs in existing substations.

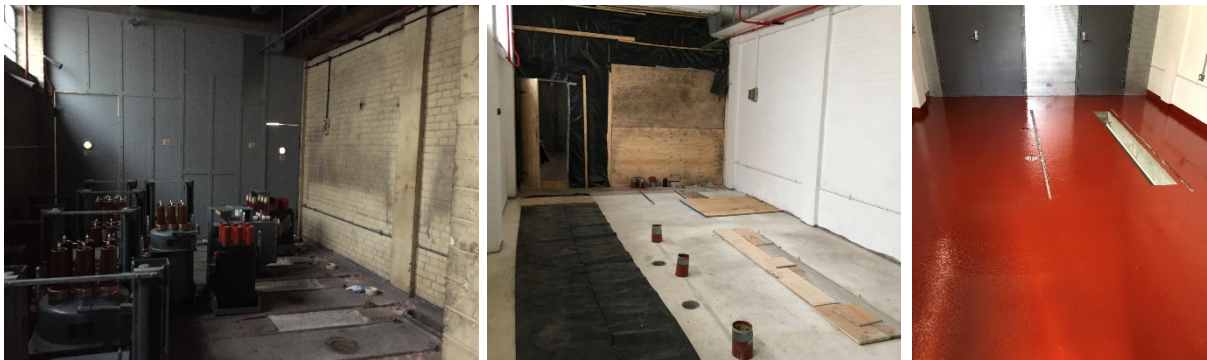
Figure 9 General sequence of works to ready the room for FLCB installation. Before works (left), screed poured and levelled, walls painted and holes drilled (middle) and finished floor (right)

The substation room earmarked for FLCB installation was previously used as storage space as shown in Figure 9. As such, the general condition of the room was unsuitable for new equipment to be installed without some preparatory work.

The stored equipment in the room was first relocated before any other works were undertaken. The next steps were to level out the floor with screed, paint the walls and to cut holes into the floor to allow access for multicore and HV cable access. The general progress of the room preparation can be seen in Figure 9 below.

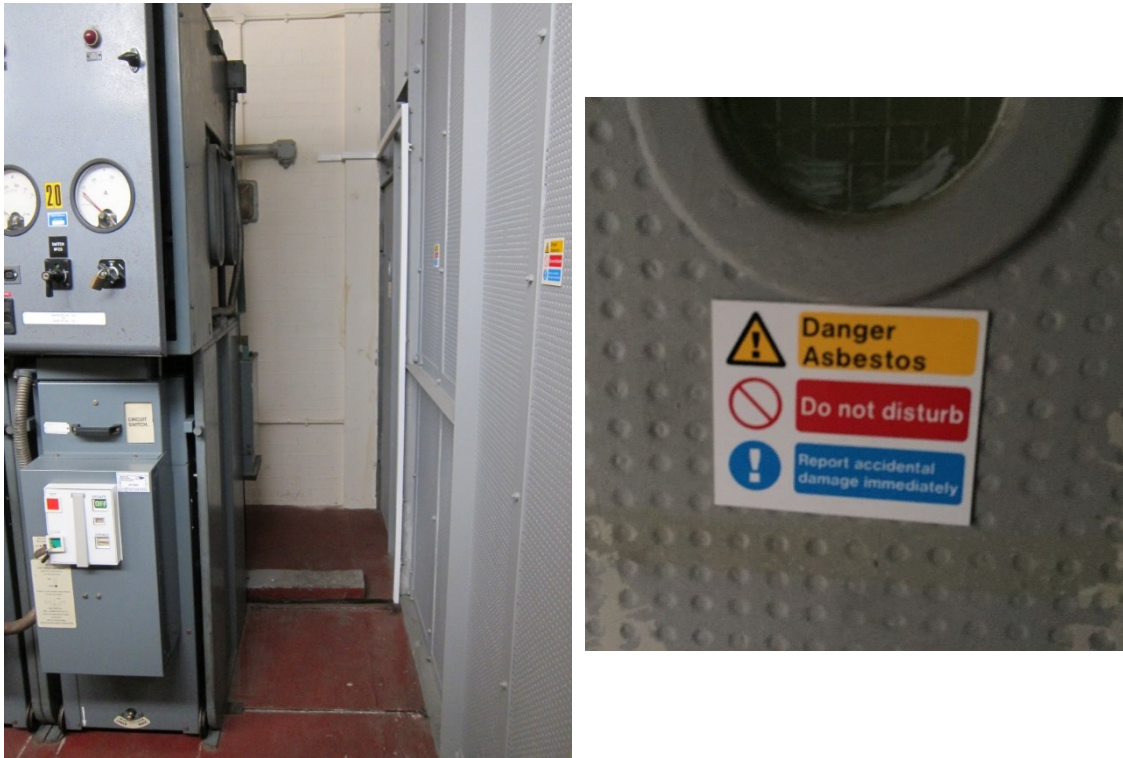
Figure 10 Existing fire protection wall requiring relocation for busbar extension which was replaced due to containing asbestos

In order to extend the existing busbar, the internal fire protection walls and doors had to be shifted due to the lack of available space as shown in Figure 10. During site selection and survey, it was observed that the existing walls and doors contained asbestos. It is well known that disturbing asbestos has the potential for serious or fatal health consequences, meaning they are unsuitable for reuse and were required to be removed and disposed of safely. As a result these were replaced with new durasteel walls and doors shown in Figure 11 which are a standard type used for their fire rated properties.

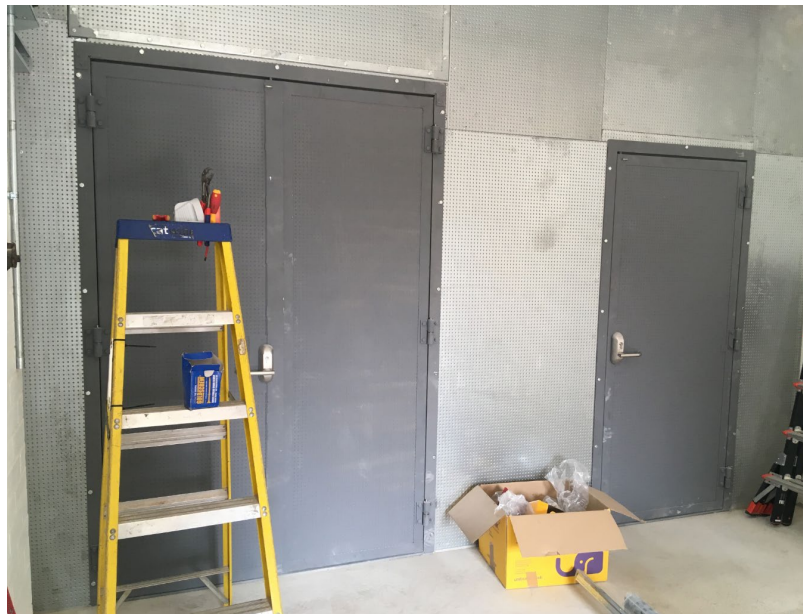
Figure 11 Newly installed durasteel wall and doors to allow for extension of the existing busbar

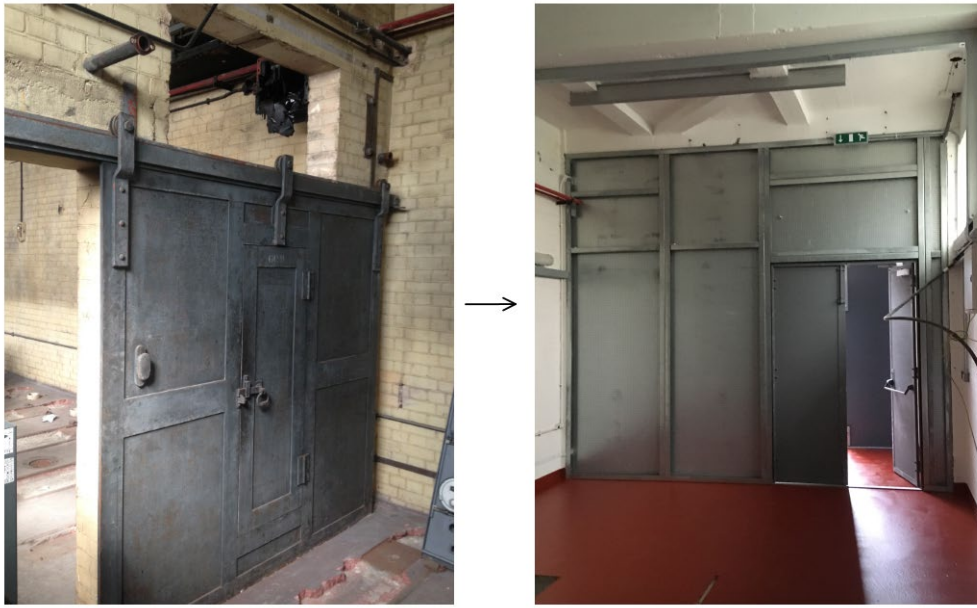
Figure 12 Second internal wall requiring replacement (left) and newly installed durasteel wall and door (right)

Similarly a second internal wall near the building entrance was replaced because it was unfit for purpose as it did not meet the requirements for separating switchgear for fire risk and as such was replaced with a durasteel one. The before and after of this work can be seen below in Figure 12.

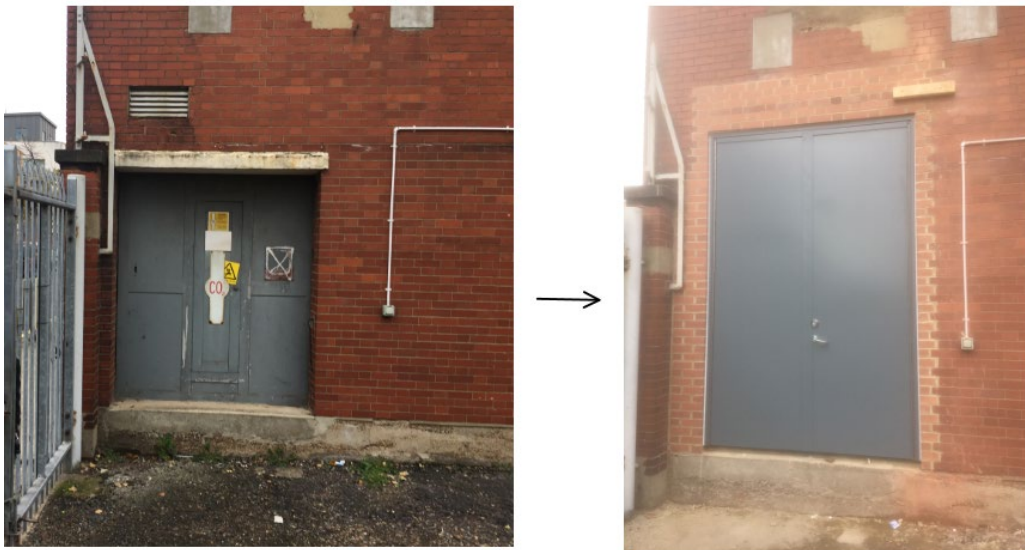
Figure 13 Existing door (left) replaced by larger door (right) to provide access for the FLCB

Finally the external door to the building also required replacing as the existing doors were not large enough to allow the FLCB to be delivered inside. The FLCB measures 2200mm in height and each panel is approximately 1000mm so taller doors were installed as per Figure 13 below to allow for delivery of the FLCB panels.

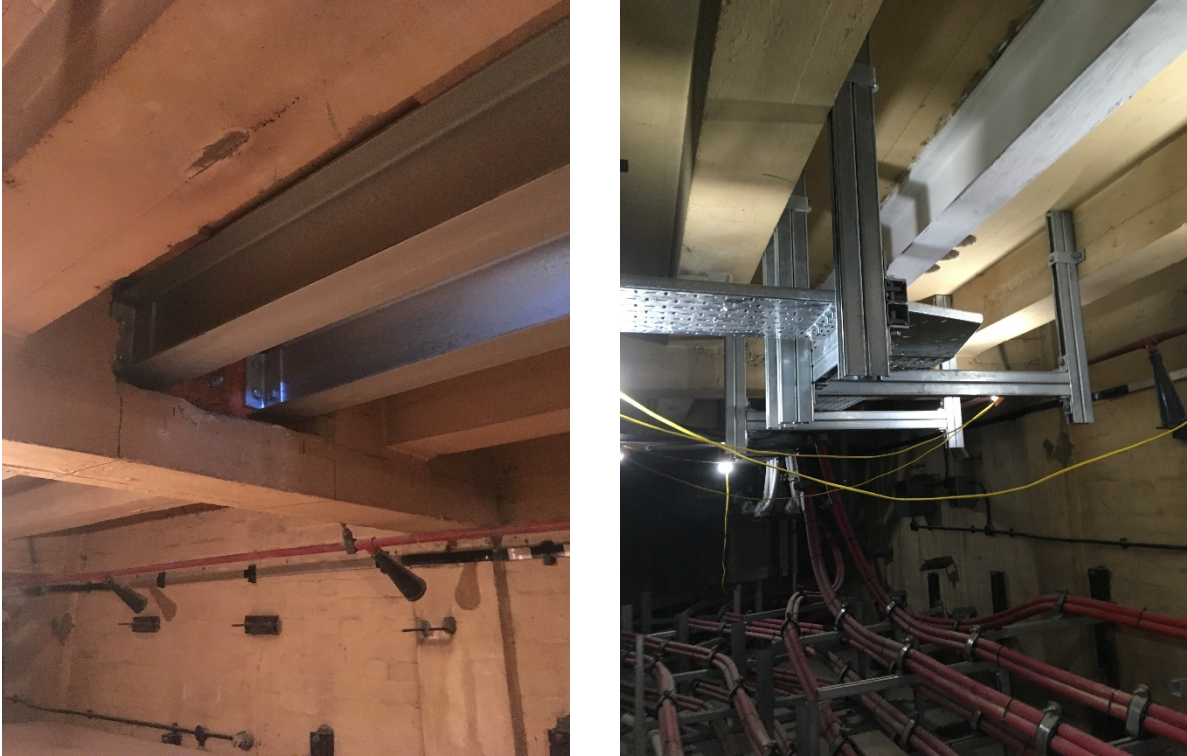
Figure 14 Supporting steelwork in the basement (left) and cable trays added for multicore cables (right)

In addition to levelling the floor and drilling holes for cable access as seen in Section 3.1, steelwork was installed in the basement to support the weight of the FLCB. Cable trays were also installed in the basement for routing of HV cables between the existing switchgear and the FLCB as well as for multicore cables from the FLCB and other relays used for protection and communications. The left image of Figure 14 below shows the supporting steelwork for the FLCB and the right image shows the cable tray used for newly installed multicore cables.

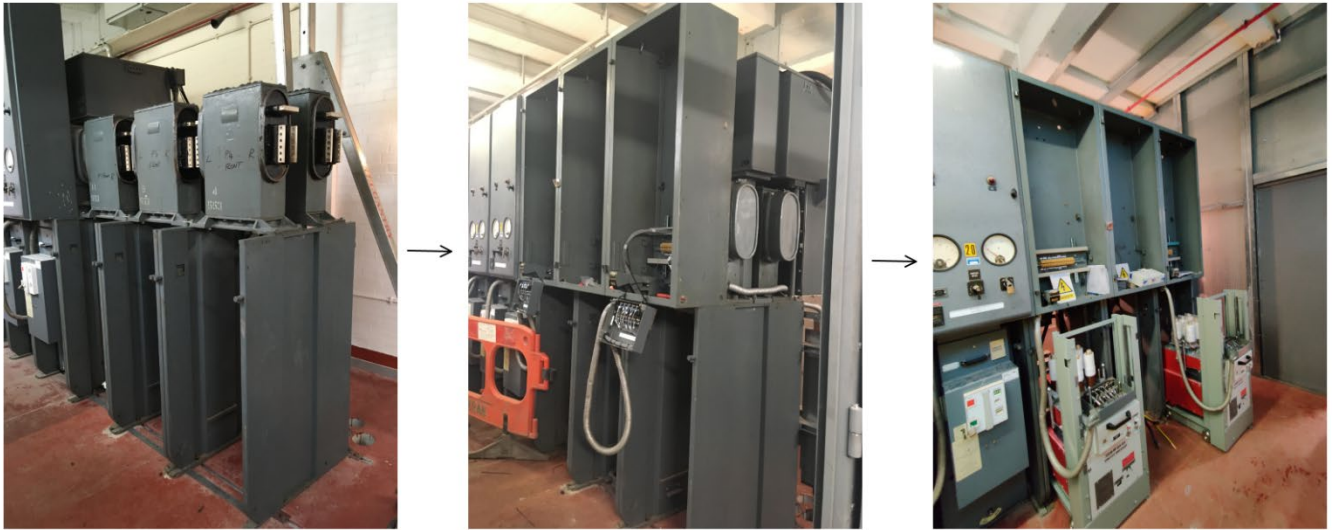
Figure 17 Sequence of work to extend the existing busbar – spare bays in place (left and middle) and retrofit circuit breakers ready to be put in position (right)

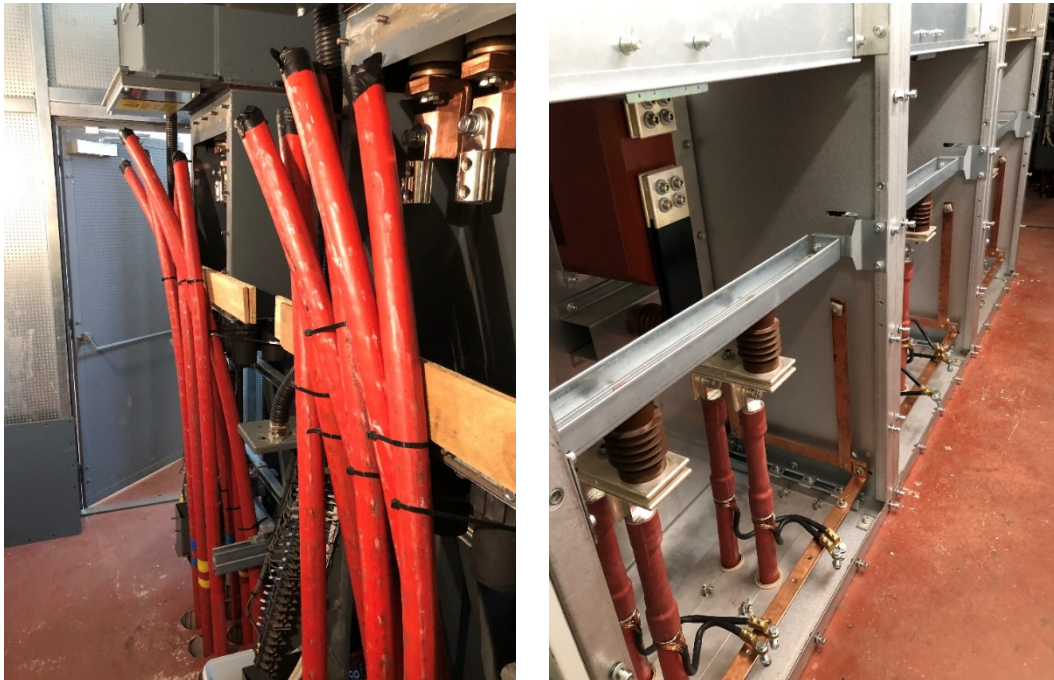
Figure 18 HV cables ready to be terminated to the existing switchgear (left) and completed HV terminations to the FLCB (right)

In order to connect the existing switchgear to the FLCB, new HV cables rated for 11kV had to be installed. Both the existing switchgear and the FLCB use bottom cable entry which means that the cables connect to the underside of the equipment. The cables then enter the basement directly below the existing switchgear and were pulled through the basement to where the FLCB was positioned and are connected to the FLCB via the slots in the floor as seen previously in Figure 9. Figure 18 below shows the HV cables ready to be terminated to the existing switchgear as well as the cables terminated to the FLCB.

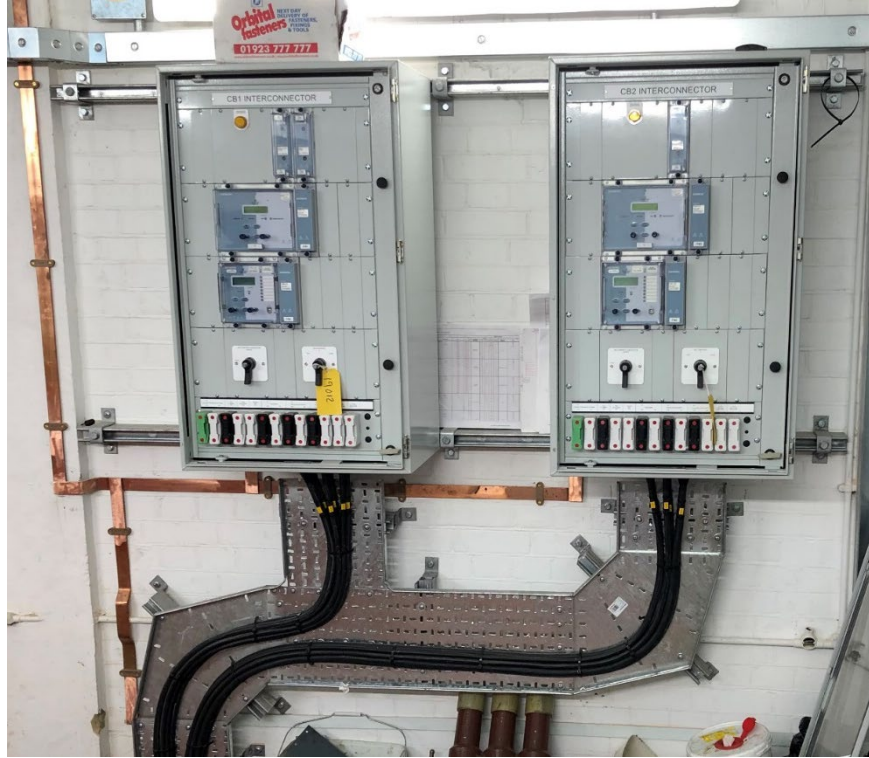
Figure 21 Protection panels house differential protection relays and overcurrent protection relays for the two adjacent circuit breakers CB21 and CB22

For further backup protection of the busbar, modern overcurrent protection relays were installed as part of the protection scheme. This is the typical requirement for protection schemes of bus couplers. These relays and the unit protection relays were installed in new wall mounted protection panels in the FLCB room because the busbar bays are unable to house the modern relays.

One of the key outputs of the project trial is data captured on the performance of the FLCB under real network conditions. It is vital that we capture this data when a fault occurs and as such we have installed external fault recorders in addition to the FLCB also having internal fault recording capabilities. As the FLCB operates at such high speeds, it was important to use equipment that is capable of recording such events. Collaborating with our project partner, ABB, we identified suitable fault recording devices capable of capturing the necessary information at a level of granularity required which was 32 measurements per cycle (i.e. 1.6kHz). The fault recorders chosen were Siemens Argus M1 units and were wall mounted in a similar fashion to the protection relays shown in Figure 21.

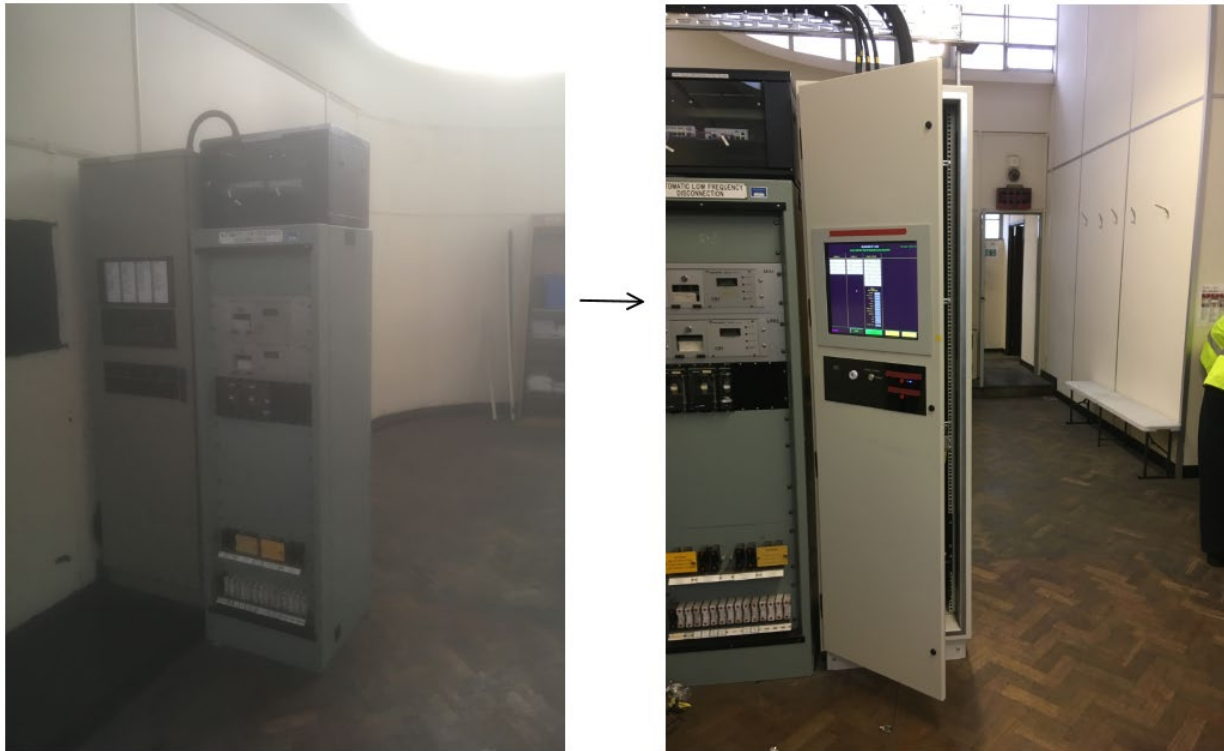
Figure 22 Existing SCADA equipment (left) and additional SCADA panel added (right) which includes Human Machine Interface (HMI)

The existing protection and control devices at the trial substation were primarily legacy equipment which do not require high capability communication infrastructure to send data back to Network Control. The introduction of the FLCB and other protection upgrades created a need to upgrade the SCADA equipment on site to provide modern digital capabilities in order to take advantage of the full functionality of the FLCB.

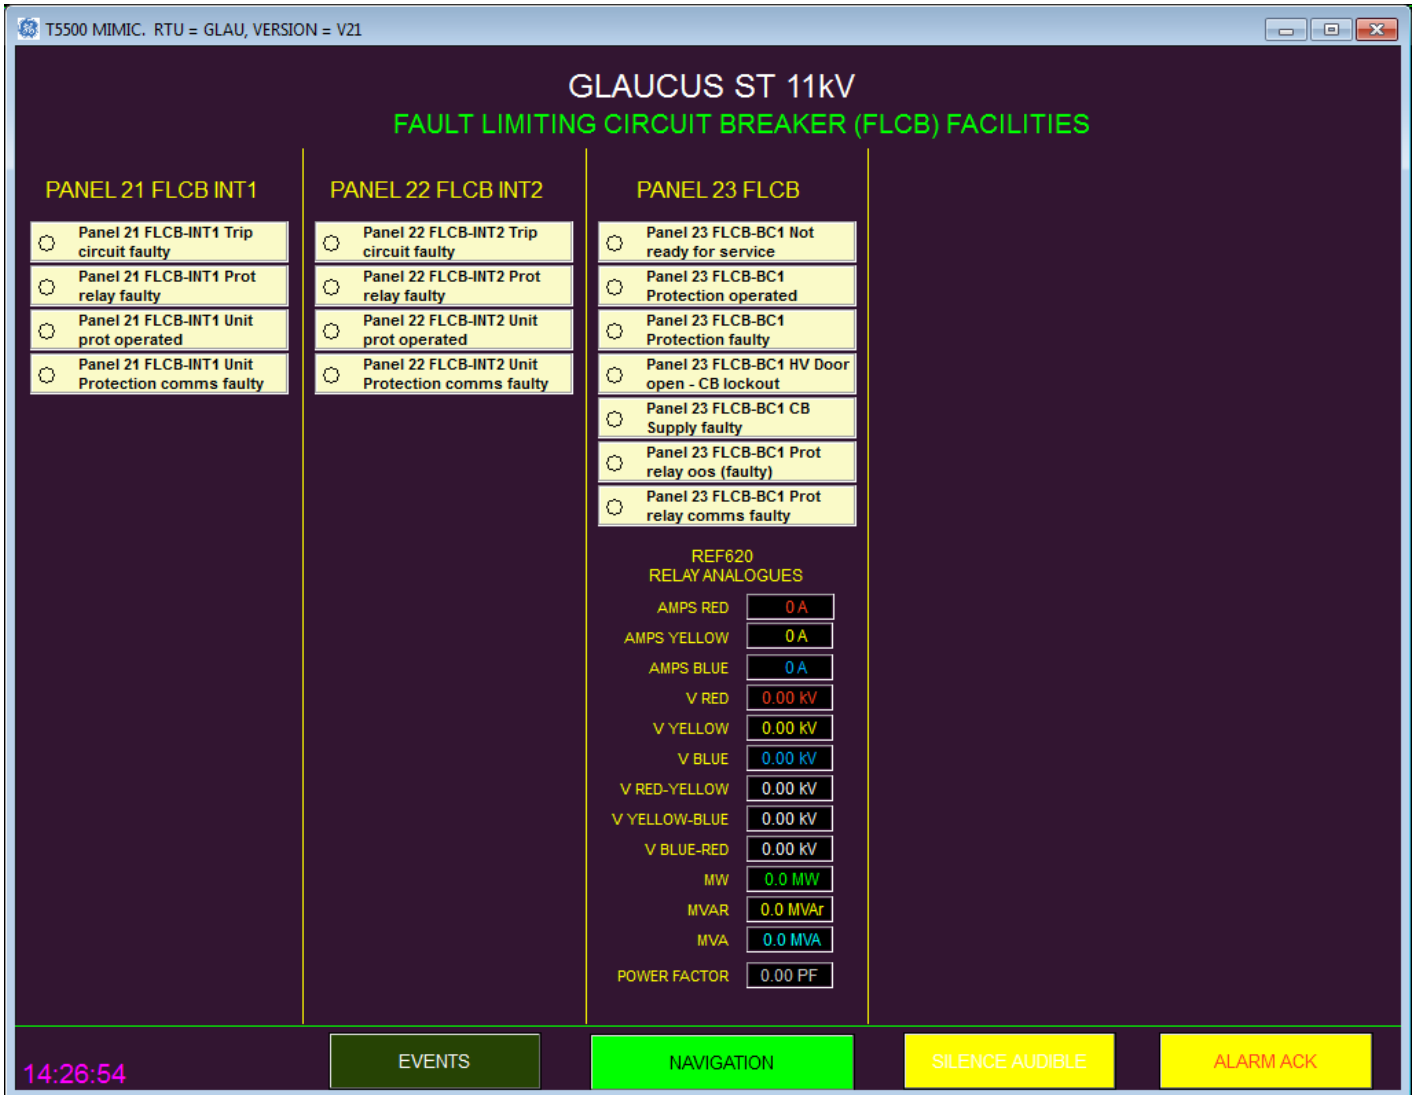
Figure 23 Display screen of HMI showing the alarms/status and analogues from the FLCB and adjacent circuit breakers PN21 and PN22

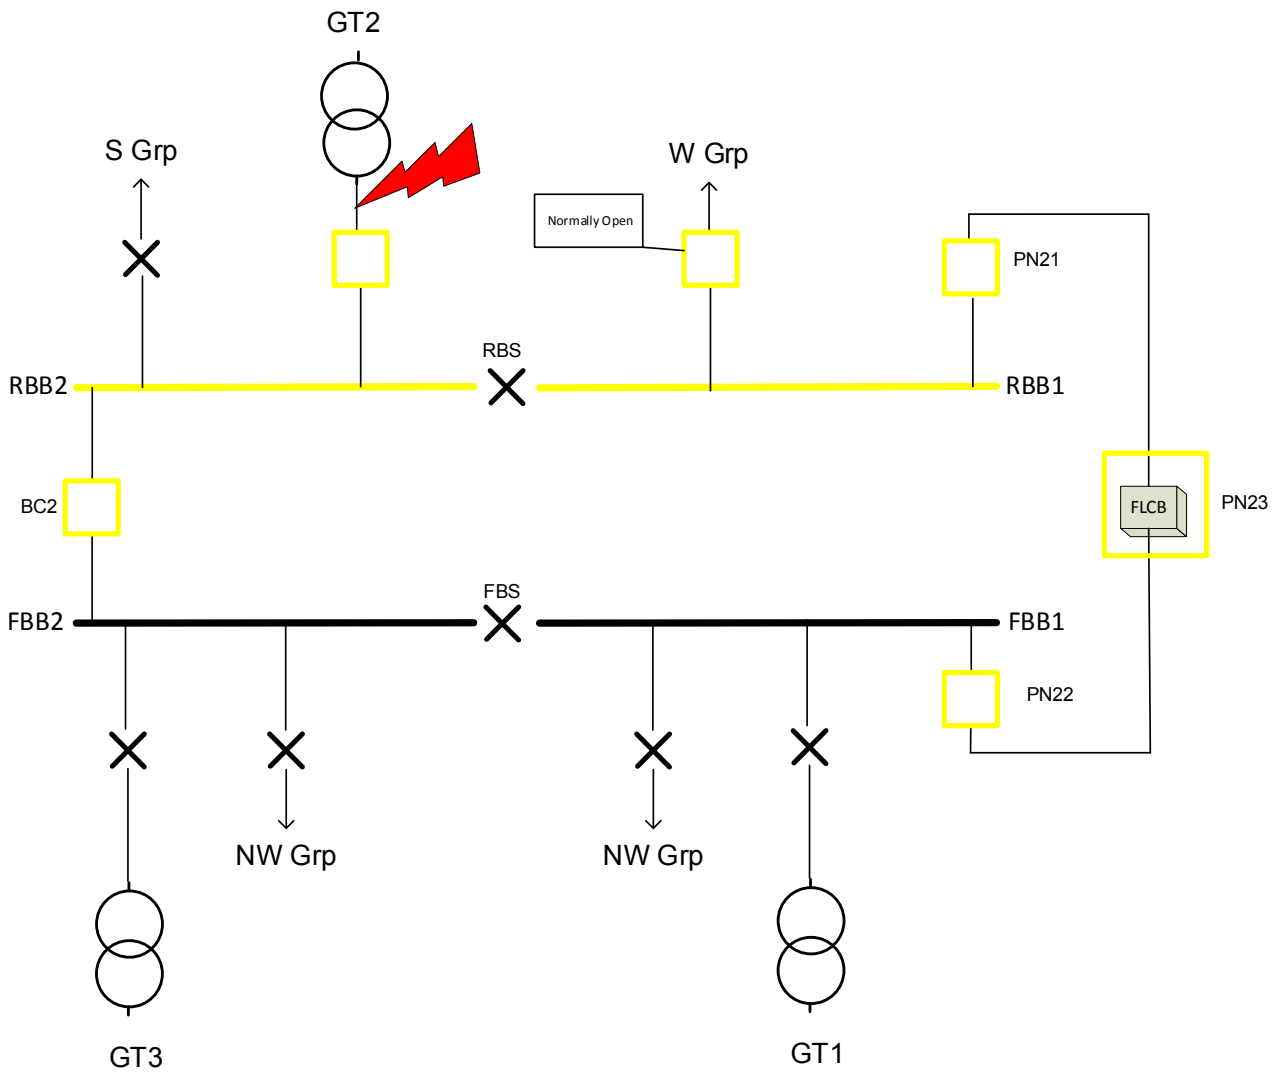
Figure 25 Fault on GT2 in Running Arrangement 3 illustrating the need for an auto-close scheme. Note yellow indicates 'de-energised'

The scenario is shown in Figure 25 where a fault anywhere upstream of the 11kV circuit breaker for GT2, the transformer protection will operate to open the circuit breaker or remote upstream protection could send an inter-trip to this circuit breaker. The fault will also be fed from front busbars, FBB1 and FBB2, via the FLCB in Running Arrangement 3 (as BC2 will be normally open in this running arrangement) and as a result the FLCB will detect the fault and trip the FLCB. With both the circuit breaker on GT2 and the FLCB open, this would leave rear busbars, RBB1 and RBB2, dead and hence have no supply.

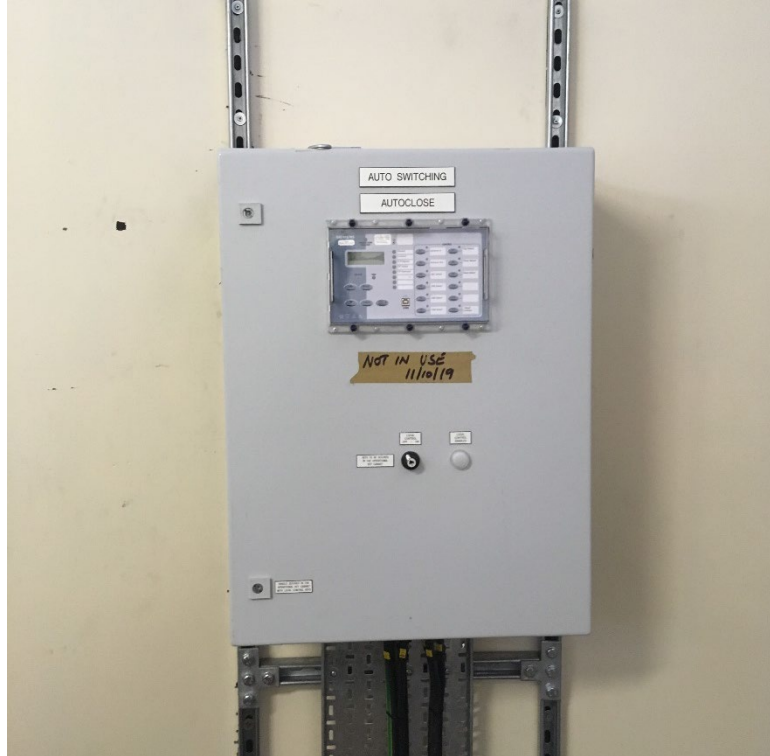
Figure 26 Auto-close panel installed

This auto-close scheme will be required on all application of the FLCB to substations with three transformers, but is unlikely to be needed on sites with four transformers. Using our trial site as an example if there were a fourth transformer connected to RBB1, there would be a transformer to support the load of RBB1-2 if GT2 were tripped and the FLCB open.

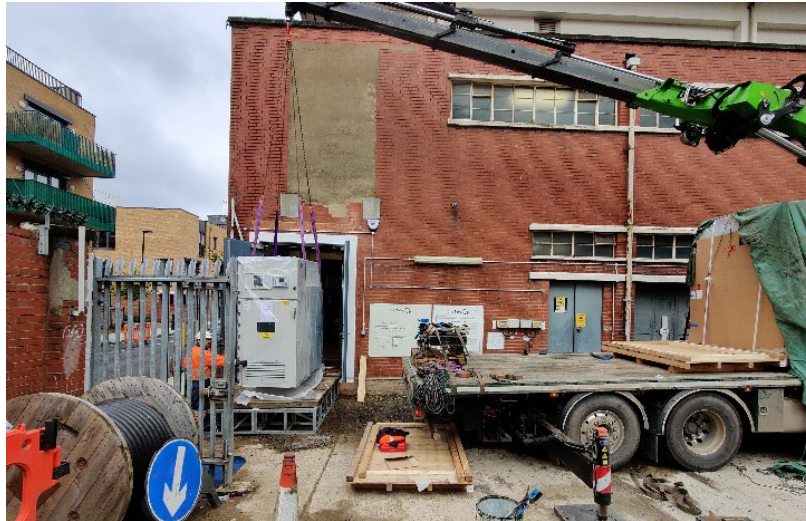
Figure 27 One panel of the FLCB being offloaded from the transportation vehicle

It was transported and offloaded on site by a heavy duty vehicle. Due to the large size of the equipment and carrying vehicle, a parking restriction was required on the road with the entrance to site. The FLCB was disassembled to three bays in the factory for easier transportation, one panel for each phase. Each panel was separately off loaded from the vehicle as shown in Figure 27 and moved inside the building with the assistance of rollers as shown in Figure 28.

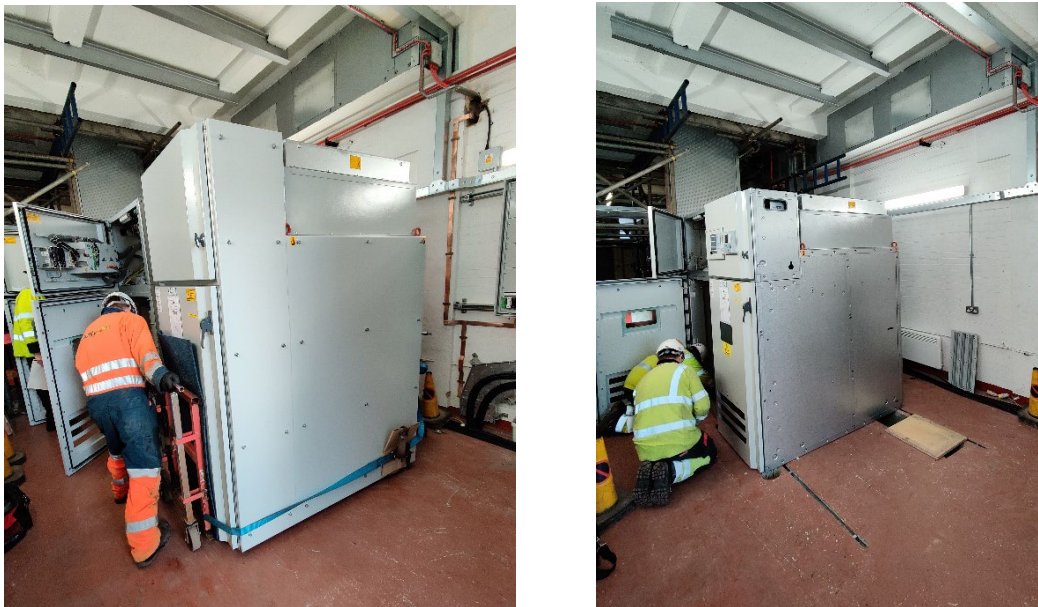
Figure 28 FLCB panels being shifted into place

After all three bays were placed in the correct position in the room, ABB re-assembled the FLCB including wiring between the panels. The wiring was for communication and control cables as the main control unit, the brain of the system, sits within the middle panel. Each phase is controlled individually by a controller in each panel respectively.

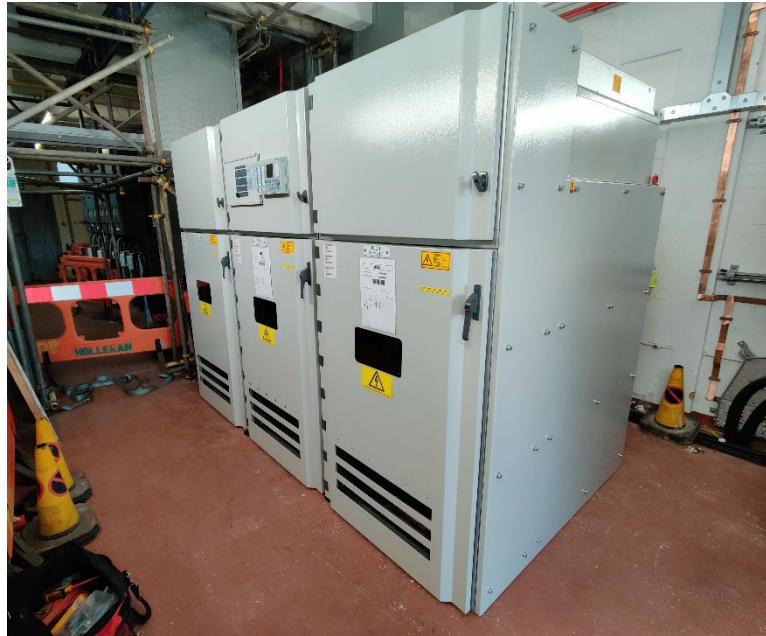
Figure 29 FLCB installed in final position and reassembled

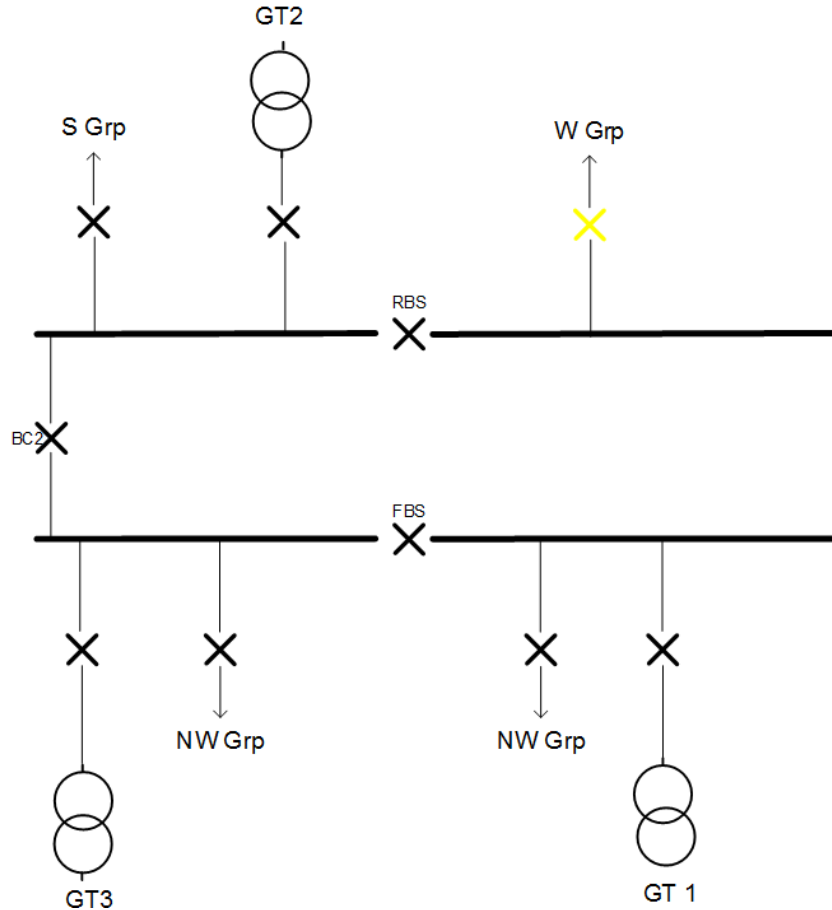
Figure 32 Standard running arrangement of trial substation prior to project work commencing. Note yellow indicates 'normally open'

In collaboration with internal stakeholders, the project team decided to trial three different running arrangements during the project trial. The purpose of having a number of running arrangements was to demonstrate the functionality of the FLCB under different topologies. The existing running arrangement of the trial substation prior to site works is shown in Figure 32 and the site is typically run solid which means that the bus coupler, BC2, was closed. This running arrangement will be referred to as 'standard running arrangement' from this point on.

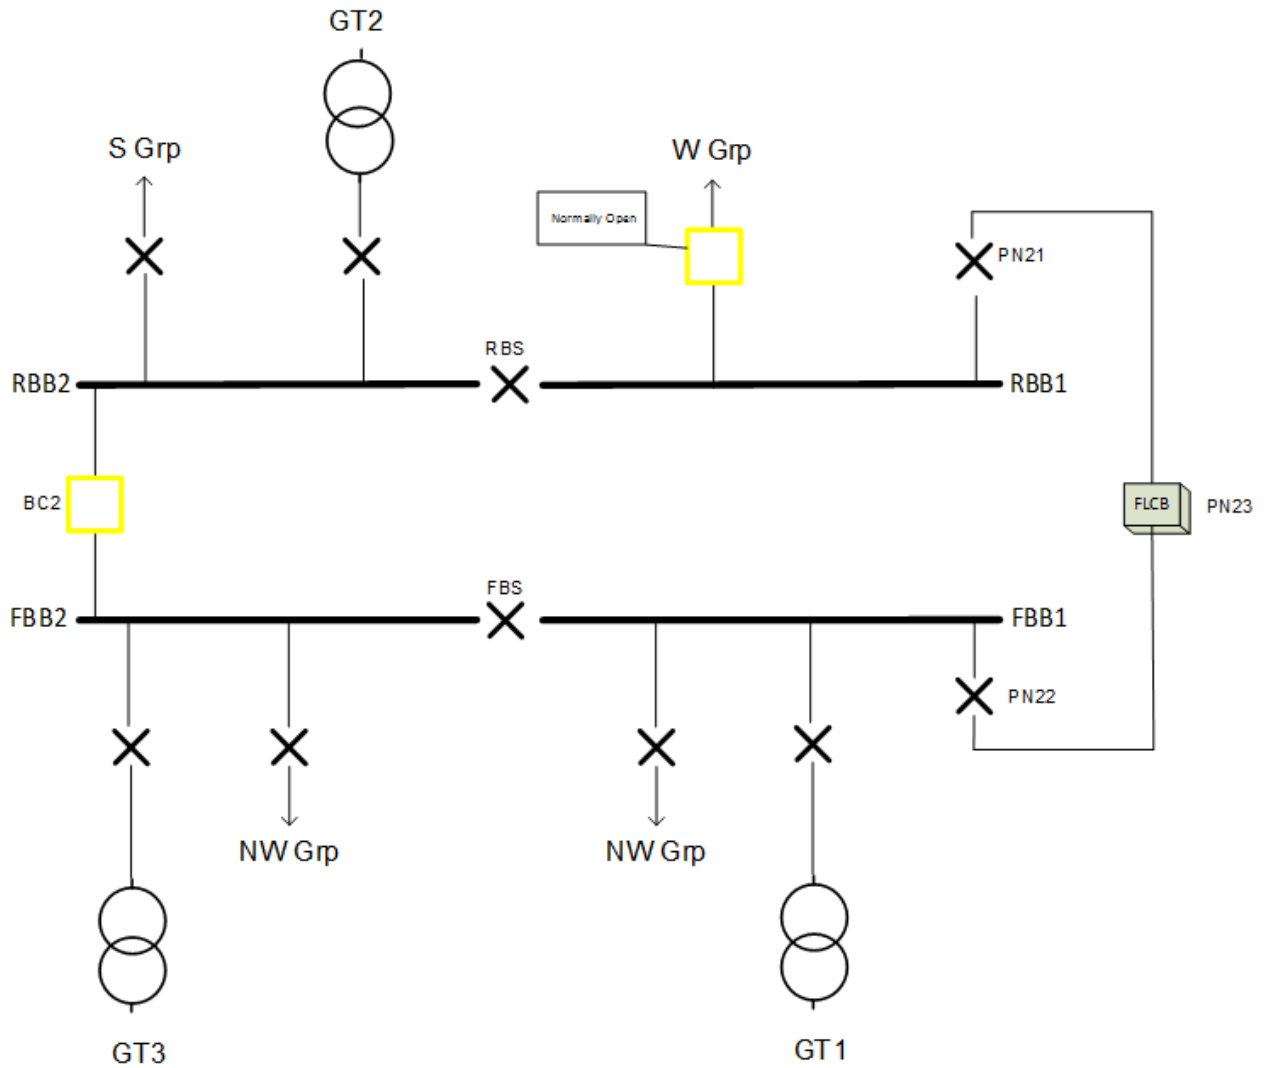
Figure 35 Running Arrangement 3. Note yellow indicates 'normally open'

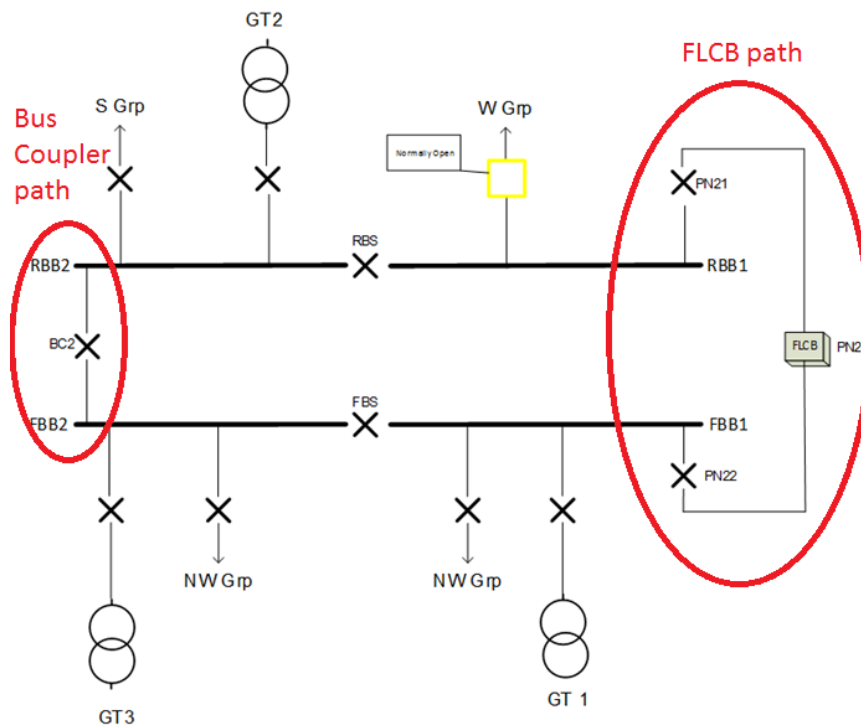
Figure 38 Running Arrangement 1 substation configuration highlighting the parallel paths between the existing bus coupler, BC2, and the FLCB

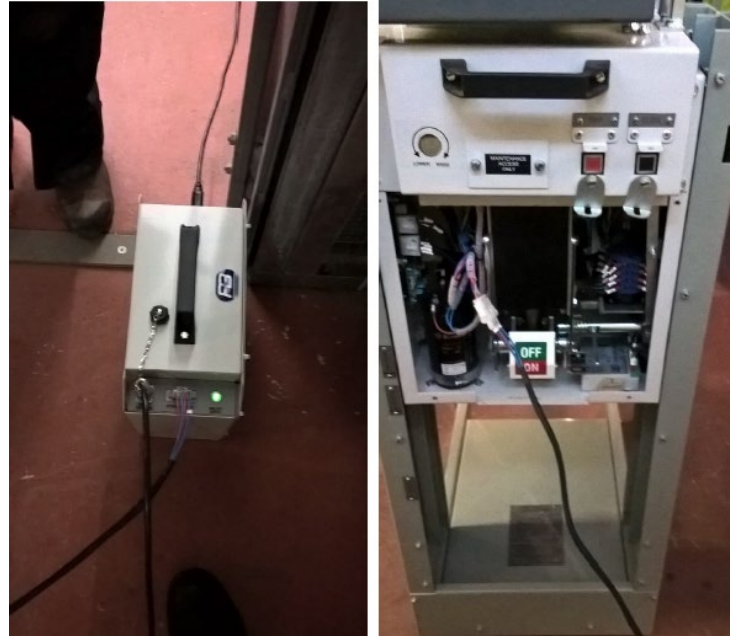
Figure 43 Portable power pack (left) plugged into retrofit VOR-M CB (right) during testing of the power pack

To operate the portable power pack, access is gained to the actuator connection by removing the front panel of the circuit breaker. Following this, the four-way connector for the magnetic actuator connection is unplugged and replaced by a connection from the portable power pack. Once this is done, the remote trip reel can be taken to another room and the circuit breaker safely opened or closed.

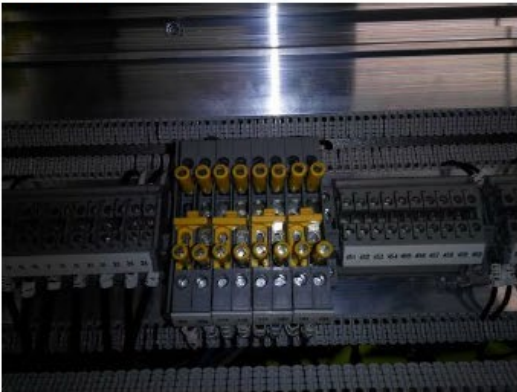
Panel =A01:

All CT terminals were in service position:
